LINE 9B REVERSAL AND LINE 9 CAPACITY EXPANSION PROJECT

PIPELINE INTEGRITY ENGINEERING ASSESSMENT

Submitted to:
NATIONAL ENERGY BOARD

Prepared by:
Enbridge Pipelines Inc. Pipeline Integrity Department

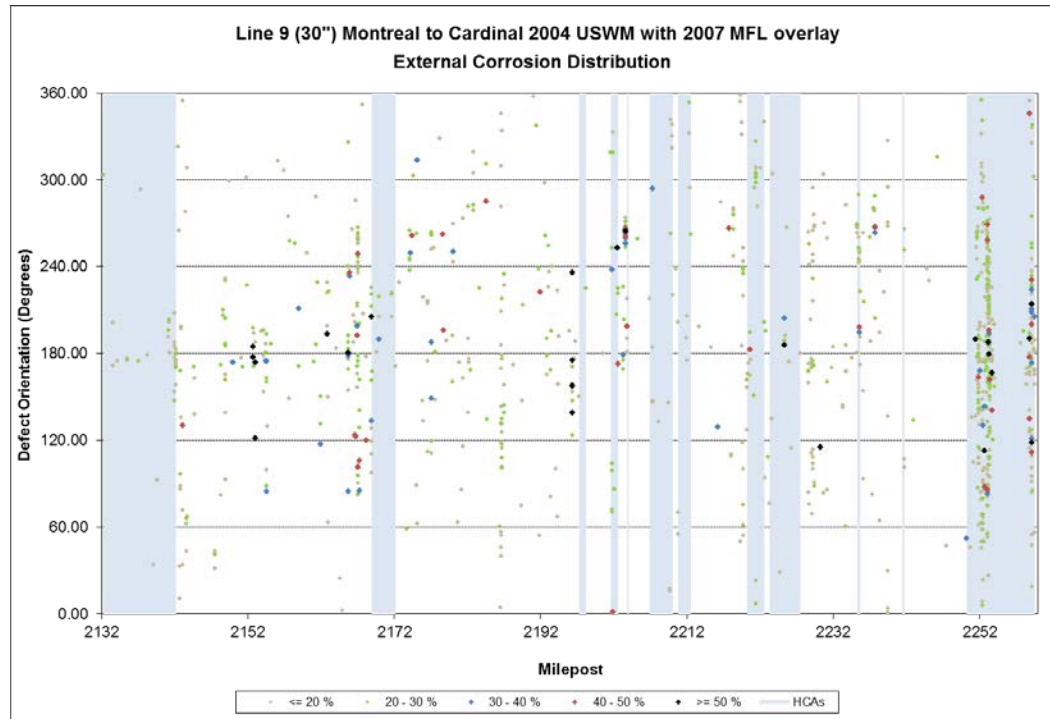
Figure 4.1 - Distribution of External Metal Loss (ML-CD)

Figure 4.1, below, shows the external corrosion distribution on the ML to CD segment of this pipeline. The reader will observe areas that appear to be “bands” of high-density corrosion between MP 2252 and Montreal Terminal (MP 2260). This is an effect of the scale of the chart, and does not indicate real-world corrosion density. All features shown as meeting Enbridge excavation criteria were excavated and repaired between 1993 and 2010.

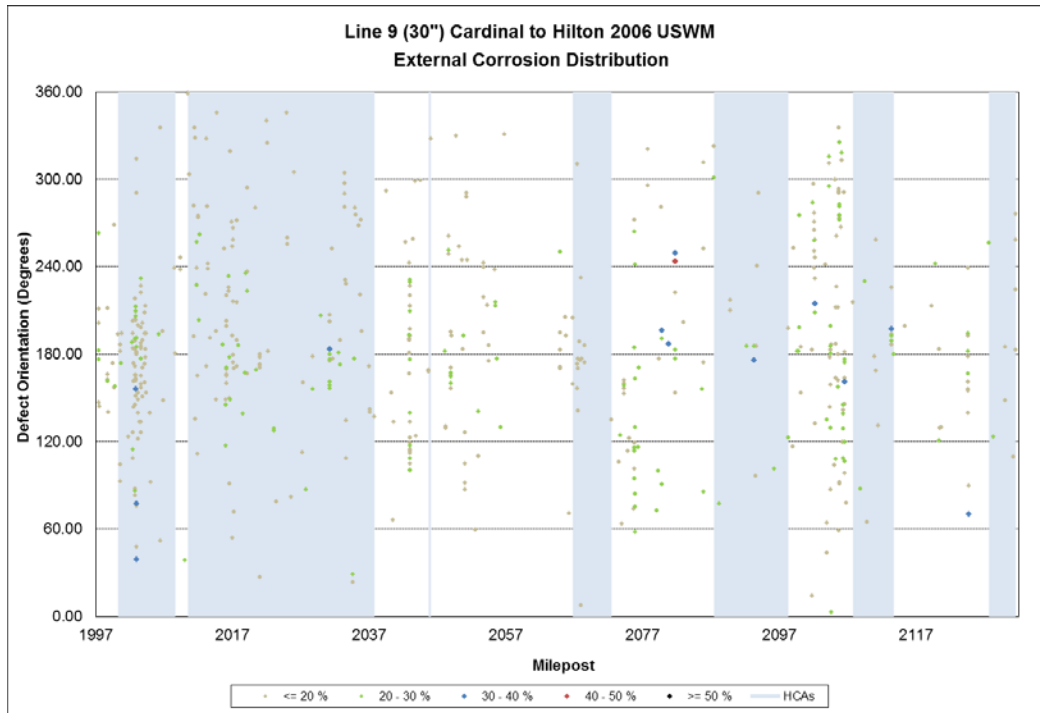
Figure 4.2 - Distribution of External Metal Loss (CD-HL)

Figure 4.2 shows the distribution of external metal loss on the CD to HL segment of this pipeline. As shown, no features in this segment met the Enbridge standard excavation criterion for depth of 50%.

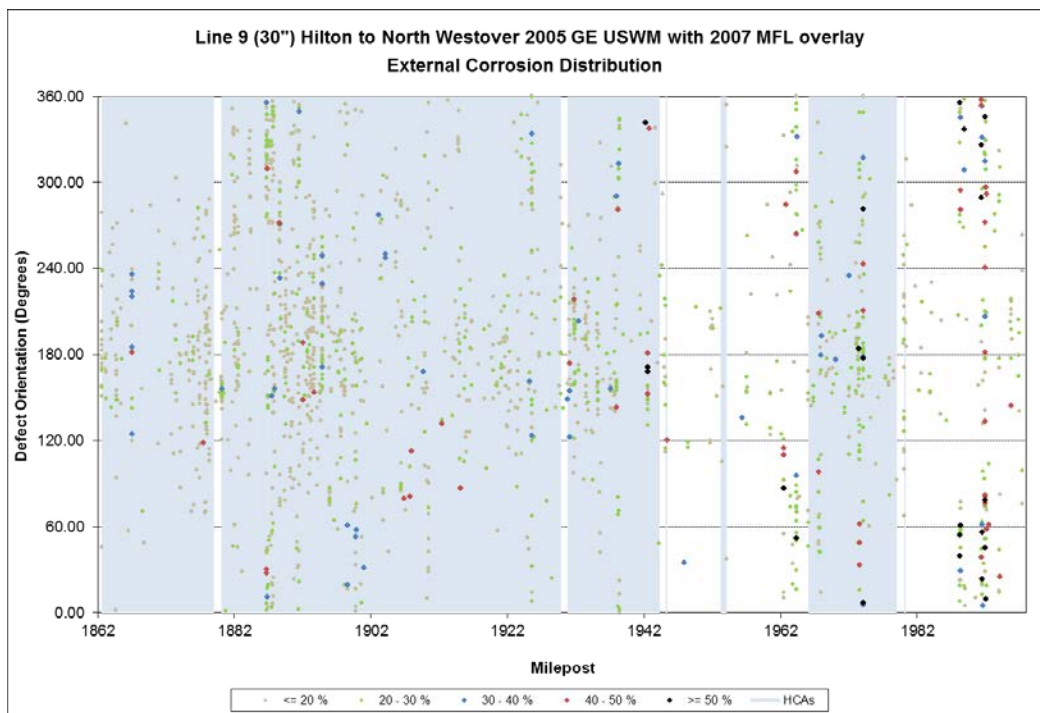
Figure 4.3 - Distribution of External Metal Loss (HL-NW)

Figure 4.3, below, shows the external corrosion distribution on the HL to NW segment of this pipeline. All features meeting Enbridge excavation criteria have been excavated and repaired.

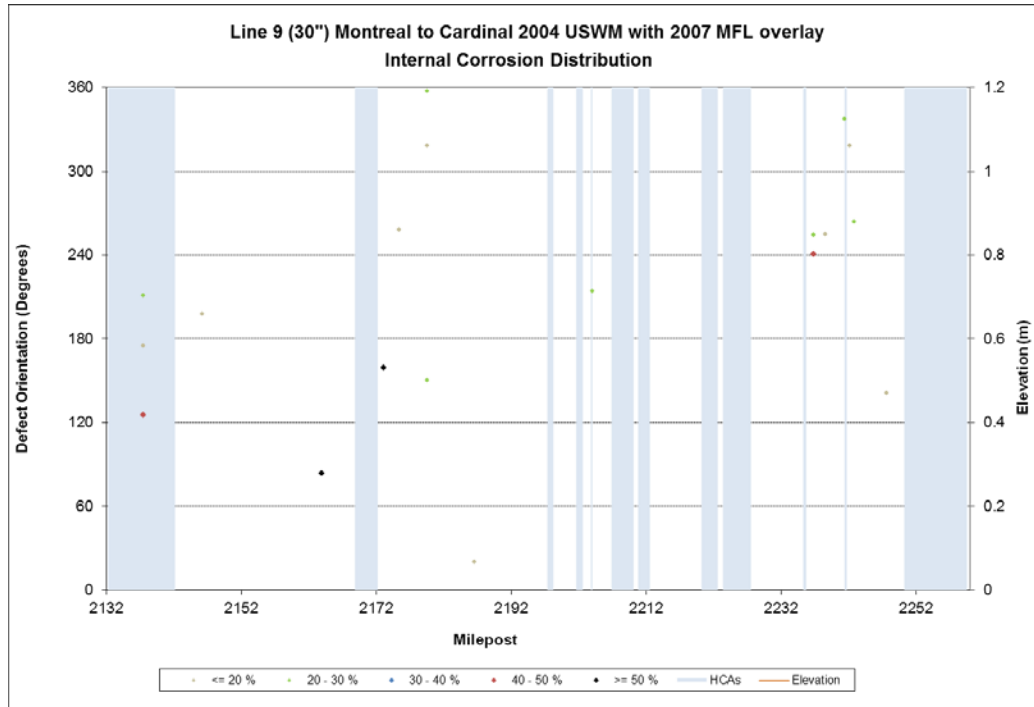
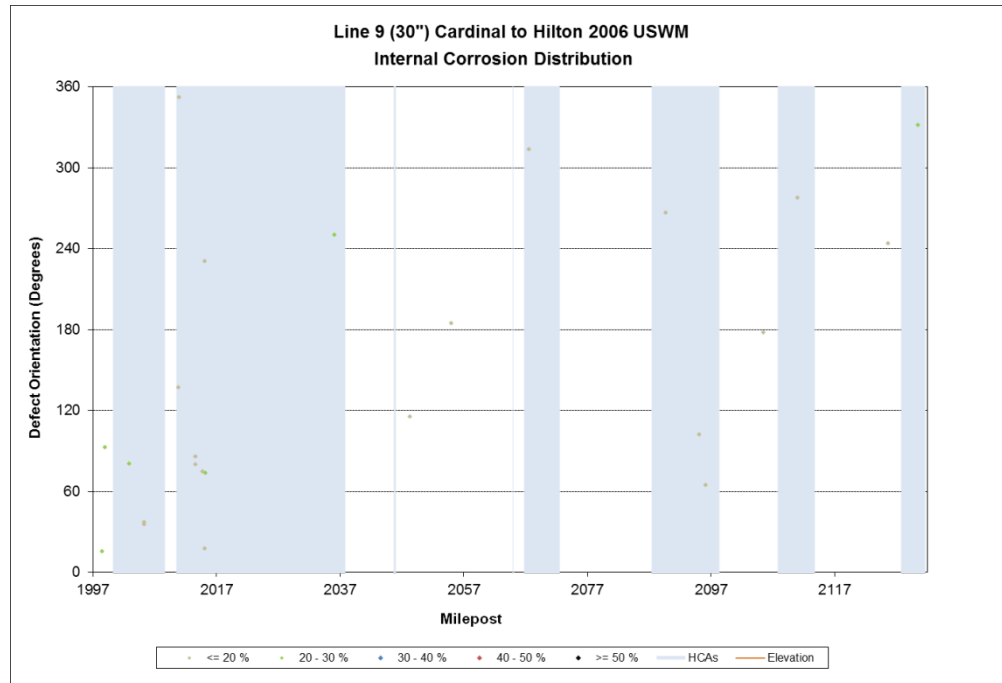
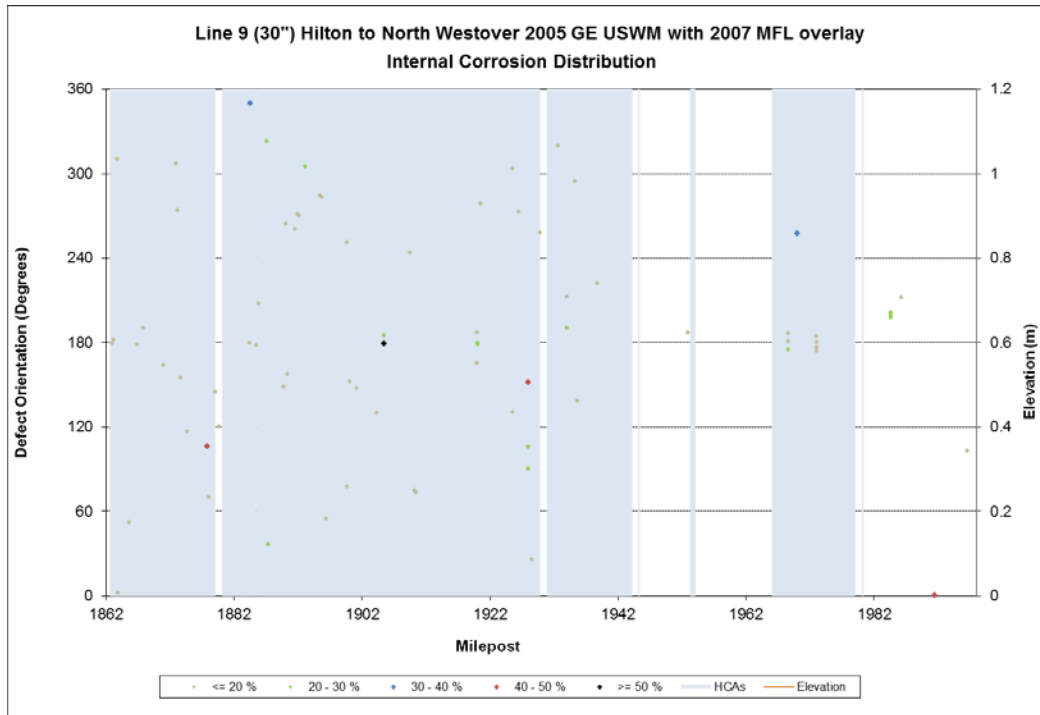
Figures 4.4 – 4.6 show the distribution of internal corrosion on the ML to CD, DC to HL and HL to NW line segments. There is no pattern of corrosion occurring on the bottom of the pipe, indicating that the internal corrosion threat is being managed. All features meeting Enbridge excavation criteria have been excavated and repaired.

According to Figures 4.1 – 4.6, there are 49 features on 35 joints that meet depth criteria for excavation. All of these features have been excavated and repaired.

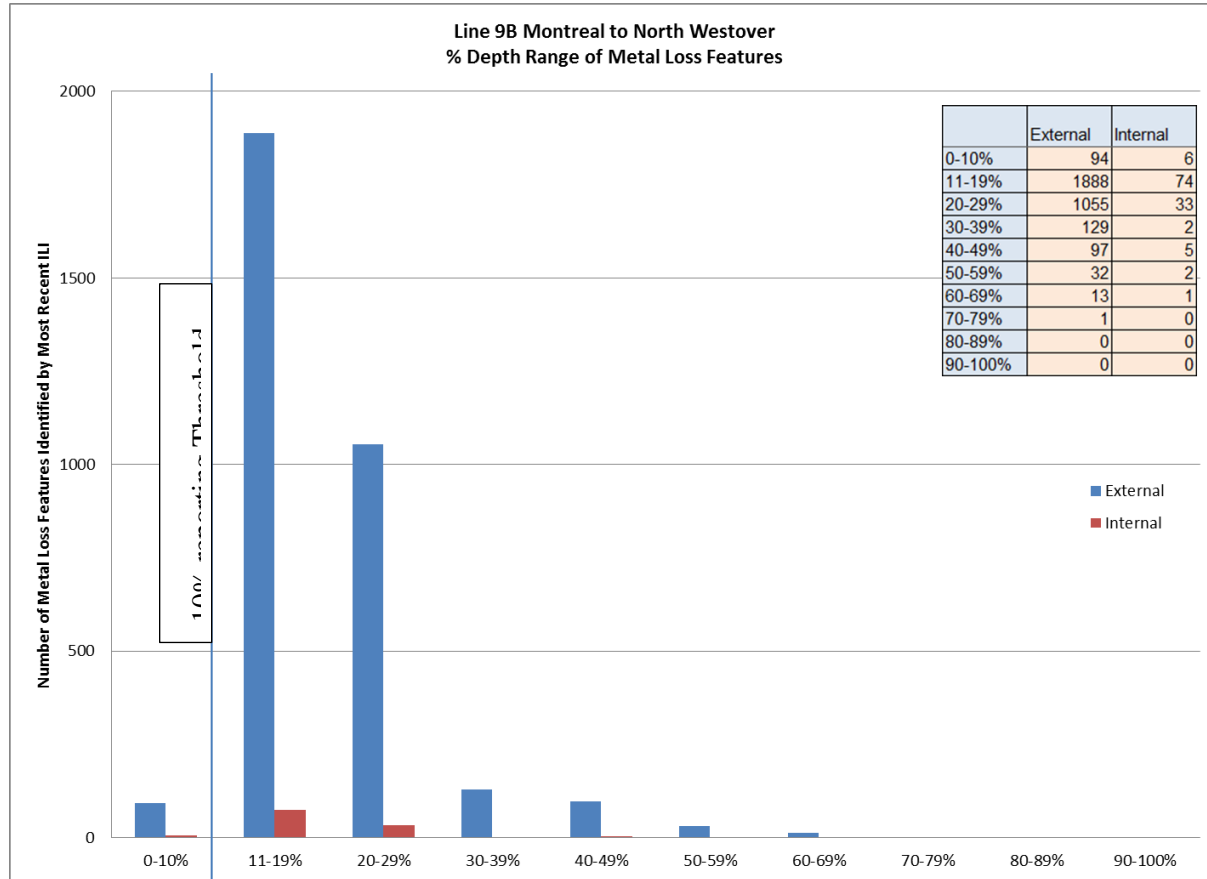
Figure 4.7 - Percent Depth Range of Metal Loss

Figure 4.7 shows the number of metal loss ILI anomalies grouped into depth ranges of 10%.

Figures 4.1 through 4.7 show that the majority of the metal loss anomalies detected are at a shallow depth and therefore do not pose an immediate threat to the integrity of the pipeline. 35 joints were identified with features meeting Enbridge excavation criterion for depth of 50%, all of which have been excavated and repaired. Features below the 50% excavation criterion will be monitored on an ongoing basis as future ILI assessments become available.

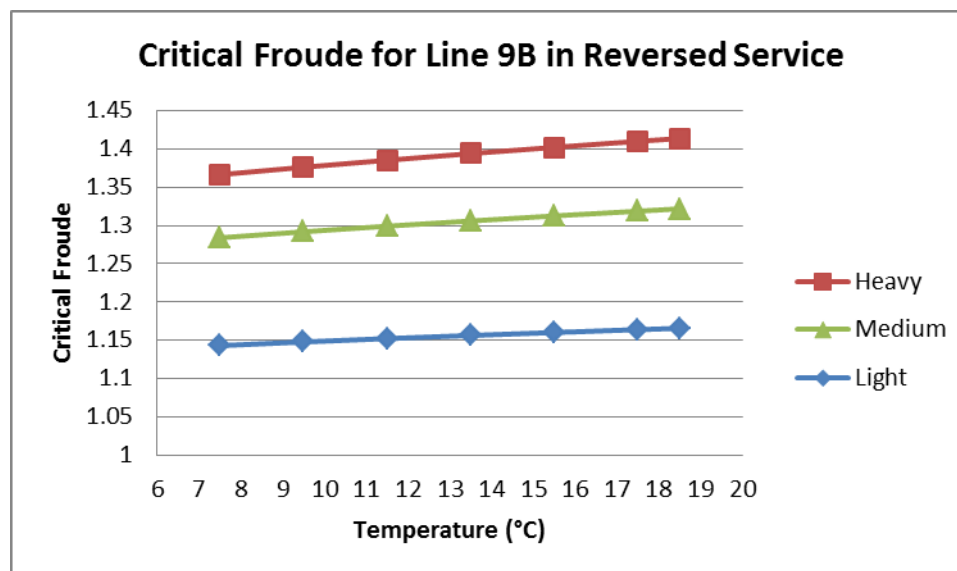
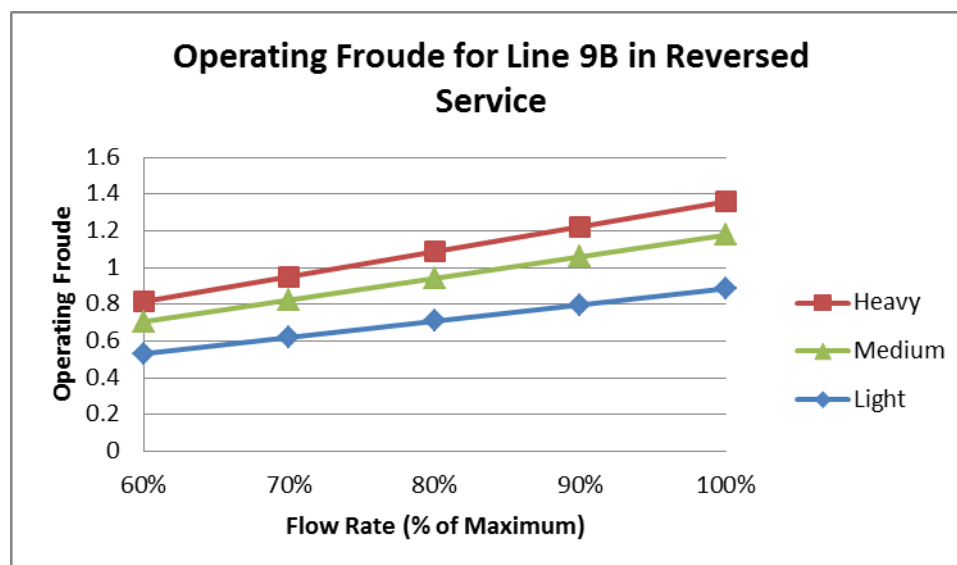
As shown in Figures 4.14 and 4.15, the proposed flow rates are not expected to achieve the critical Froude number, the Froude value at which water can be fully entrained in the product. As such, a prevention program has been planned to displace corrodents on a regular basis through routine maintenance via in line cleaning tools.

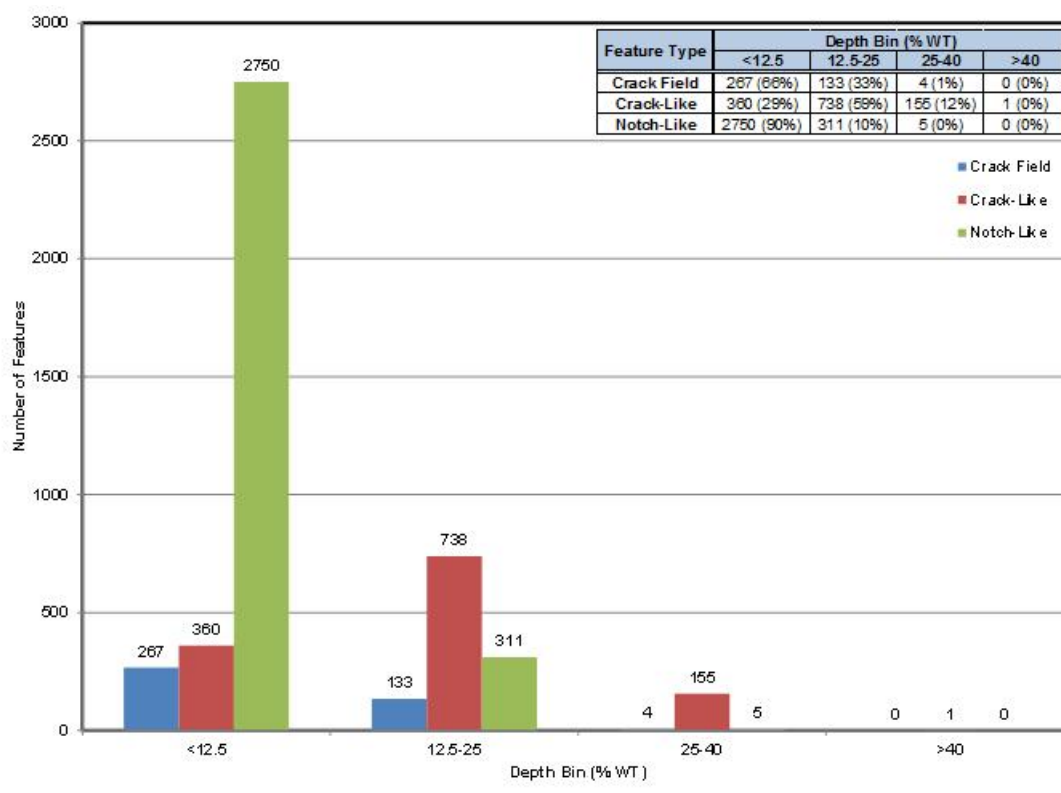
Figure 4.27 - Depth Distribution, All Reported Features (NW-ML)

14 Illustrated in Figure 4.27, approximately 72% of the reported features for which depth was
15 provided had a reported depth of <12.5% of the pipe WT, while only one (0.02%) of the reported
16 features had a reported depth >40% of the pipe WT. The feature with a saturated signal (i.e.
17 >40% depth) was reported on the CD-HL segment of Line 9B and was found to be
18 approximately 44% depth in the field in 2007.

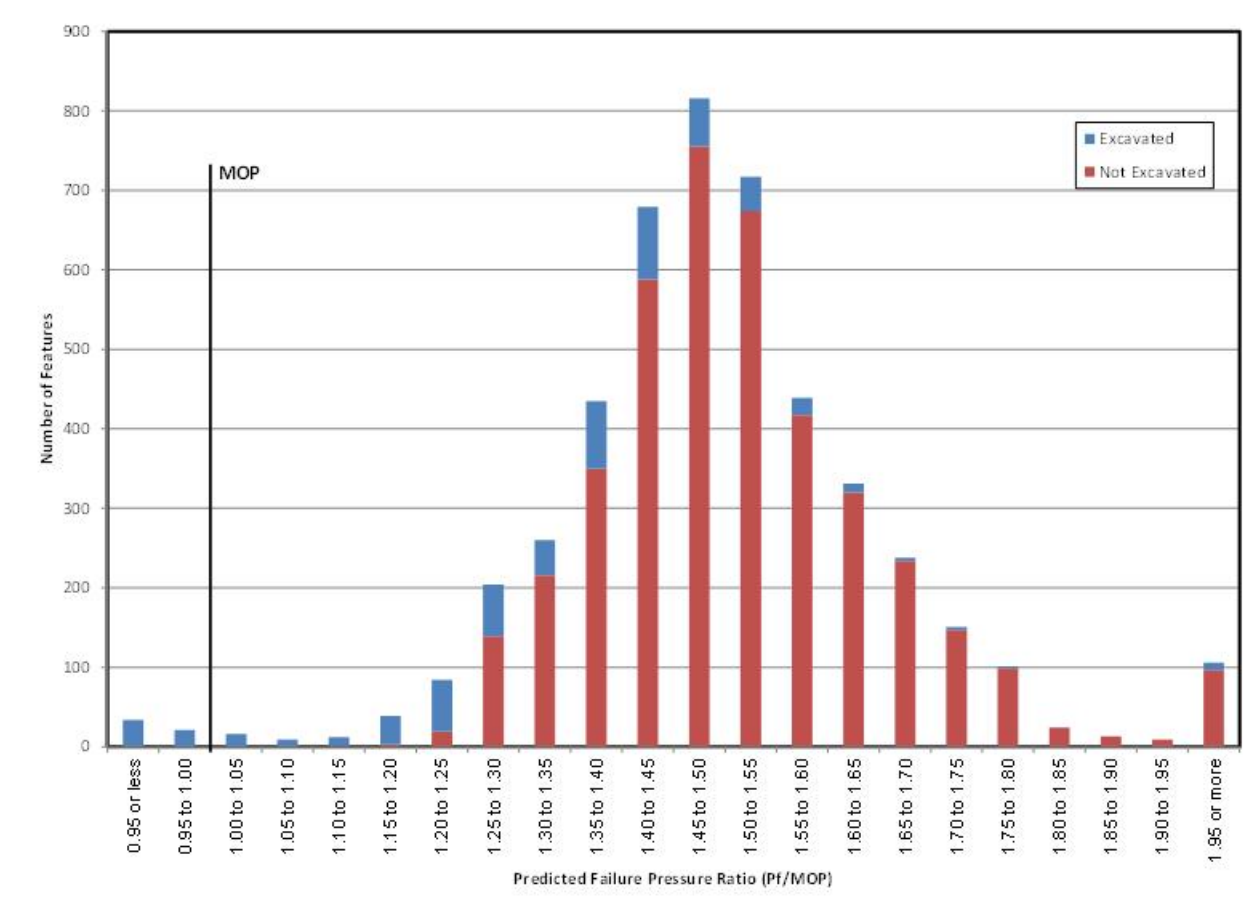
Depicted in Figure 4.28, there are 184 features with Predicted Failure pressure (“Pf”) less than MOP or 125% of MOP based on Enbridge’s current integrity processes. The lowest calculated failure pressure is 86% of NEB-approved MOP or 212% of the current reduced operating pressure. Of the 172 features excavated to date, no feature was found in the field to actually have a predicted failure pressure less than MOP. The Lowest Pf/MOP value confirmed in the field is 1.12, whereas the Pf/MOP for the same feature based on ILI data was 1.24. The lowest factor of safety for features remaining on all three segments is 193% of the current reduced operating pressure.

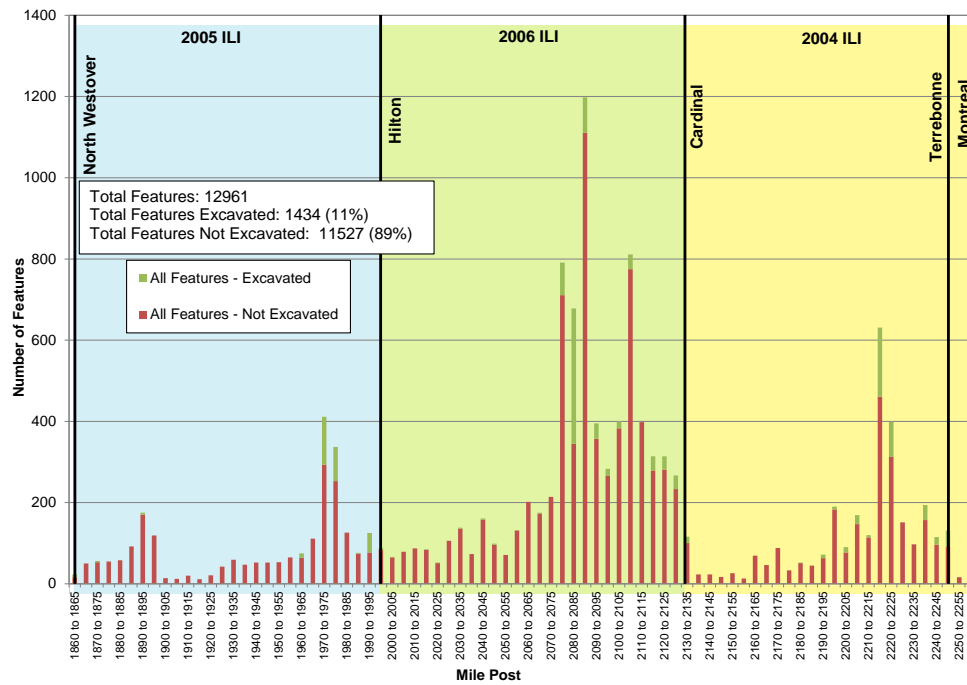
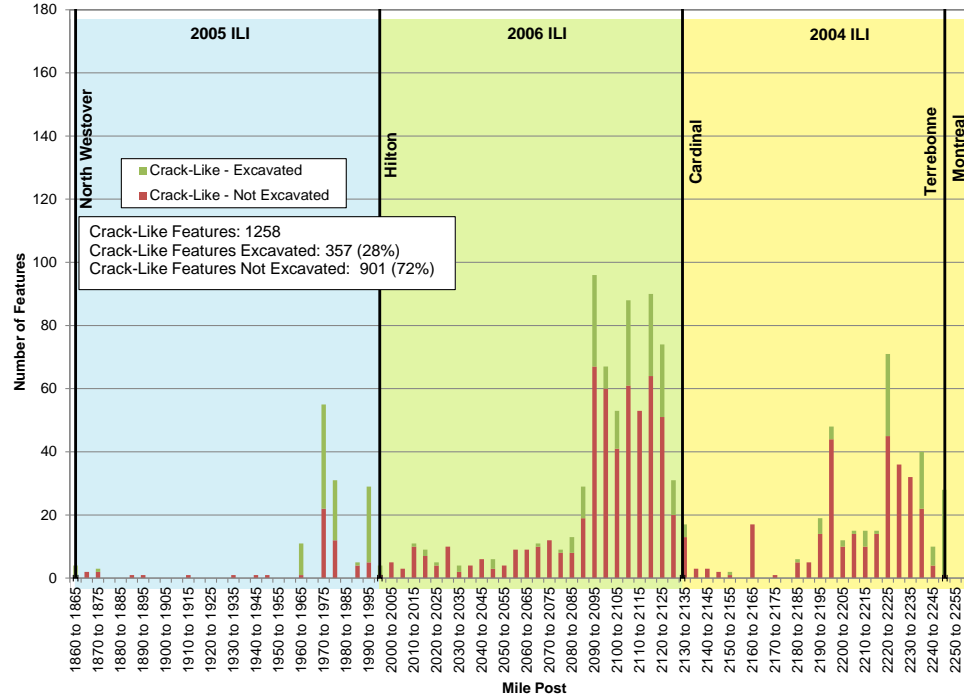
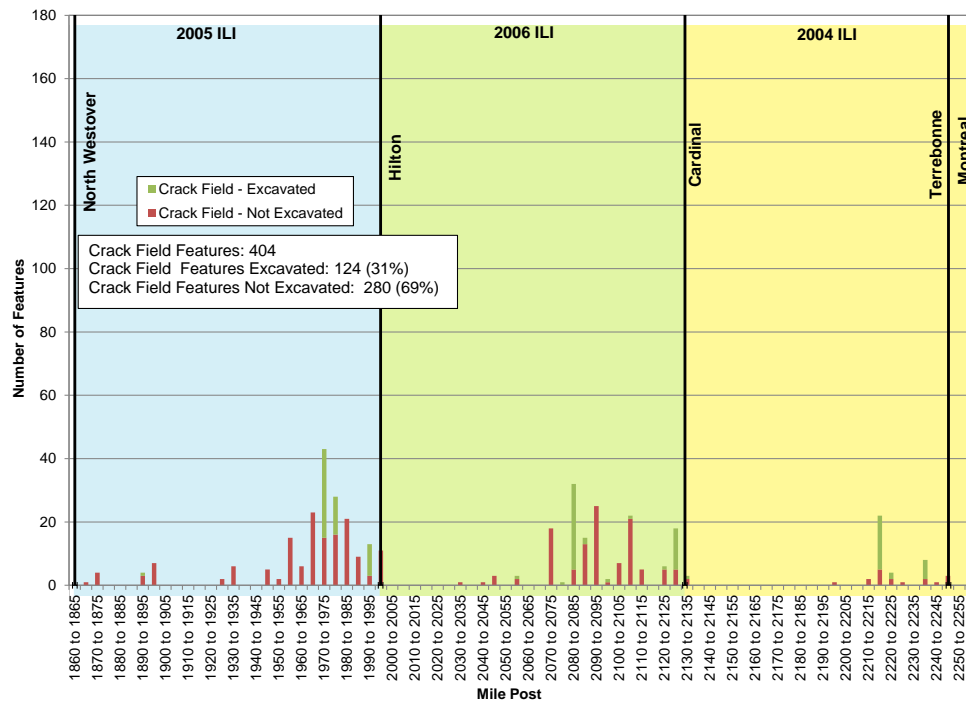
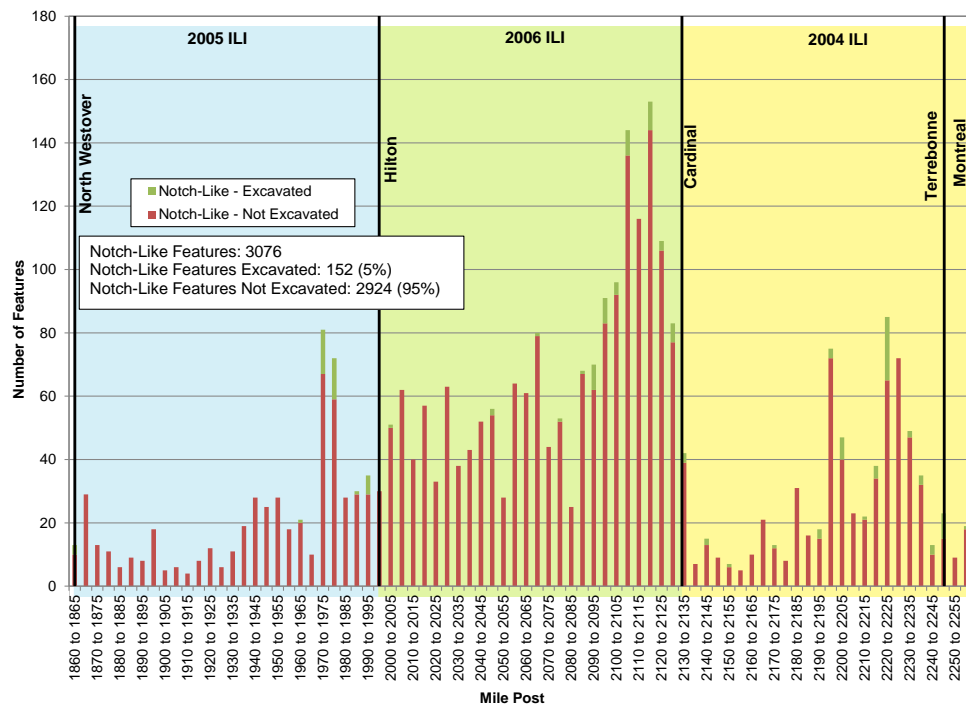
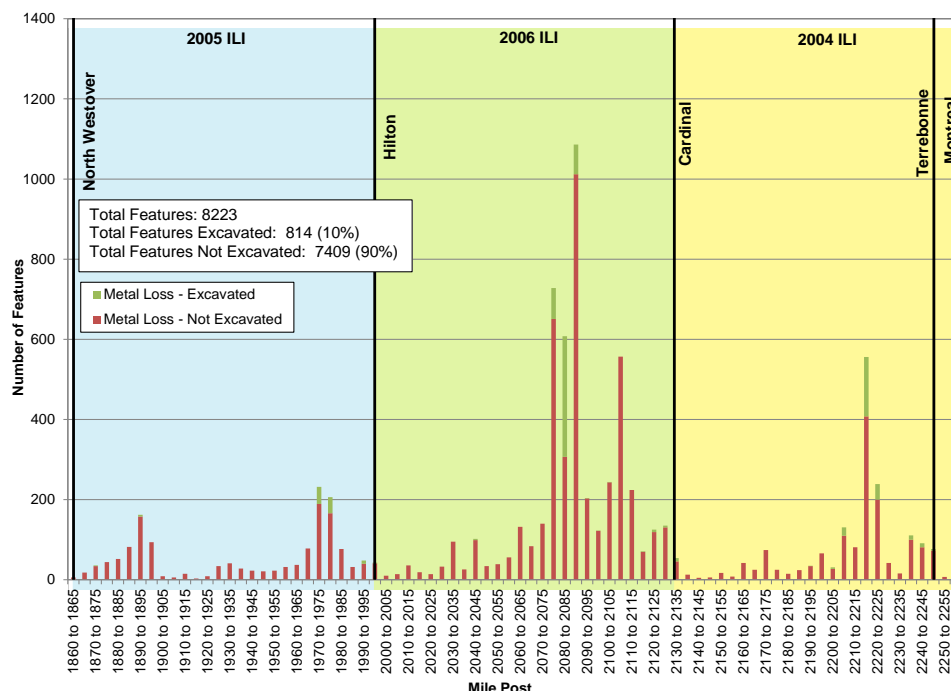
As depicted in Figures 4.29 to 4.33, there are features reported throughout the length of Line 9B between NW and ML; however, there is a higher overall concentration in the section between HL and CD, as well as relatively higher concentrations in closer proximity to the current discharge side of the pump stations. Approximately 43% of digs completed on Line 9B were within the HL to CD section, and overall, approximately 83% of completed digs were within first 50 miles downstream of a discharge pump.

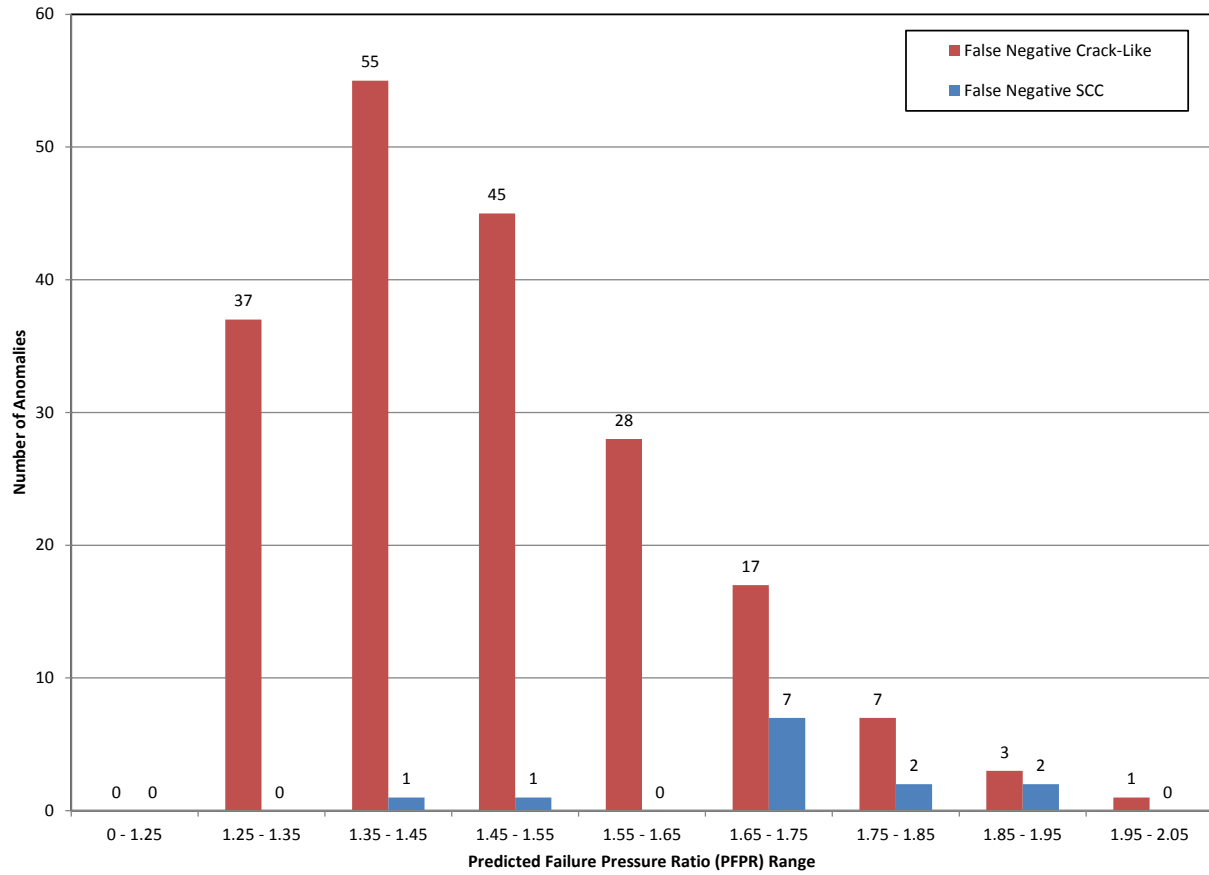
**Figure 4.35 - Predicted Failure Pressure Ratio Distribution
(False Negative Features Detected in the Field)**

Shown in Figure 4.35, the lowest predicted failure pressure of the 193 false negative CL features is equal to 125% of the NEB-approved MOP, while the shortest remaining life of these 193 features is 36 years (refer to Figure 4.36 and Table 4-10). Thus, based on this information, CL features not reported by the crack detection tool can be managed through ILI feature detection enhancements, subsequent ILI, and pipeline rehabilitation, and do not pose an immediate threat to the integrity of the pipeline.

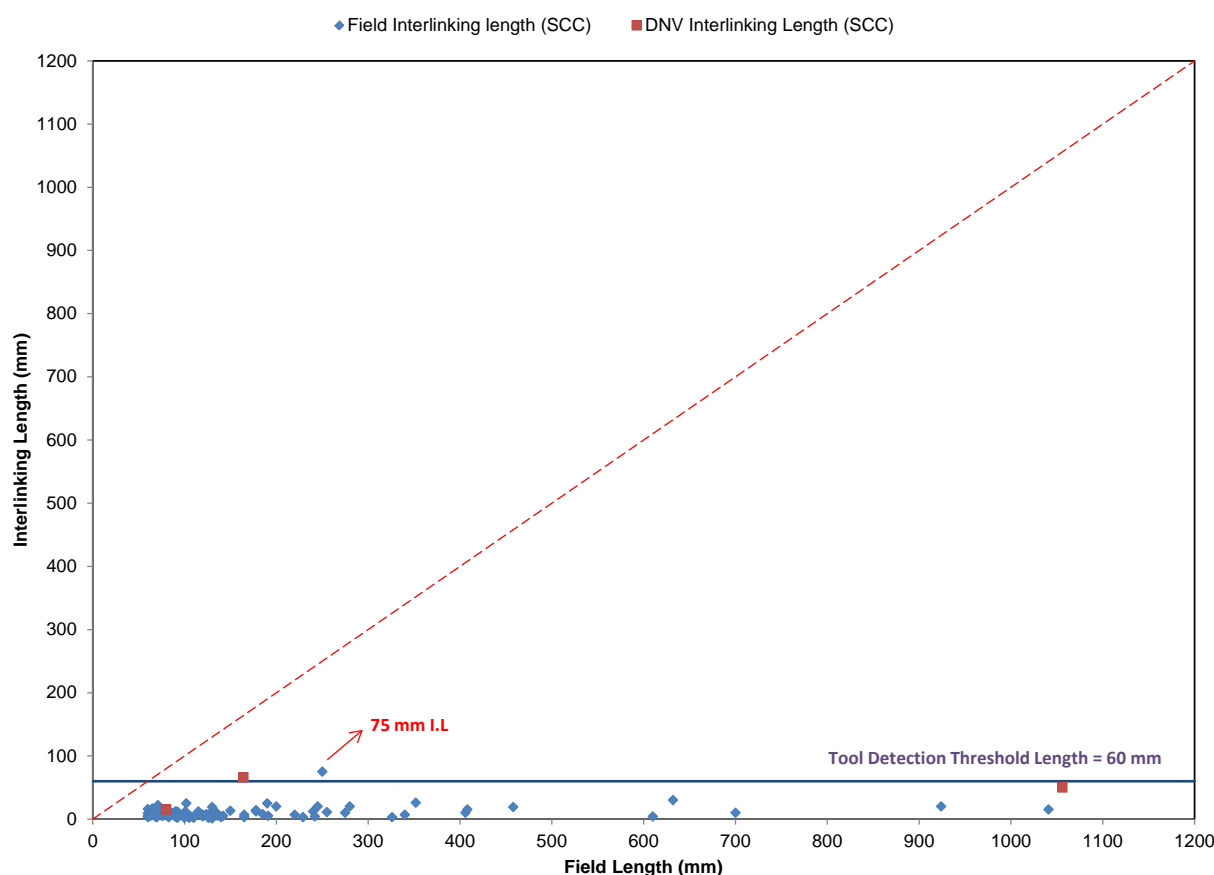
**Figure 4.37 - Total Field Measured Length vs. Longest Indication
(or DNV Verified Longest Interlinking Length) for Unreported SCC Features**

Illustrated in Figure 4.37, the field measured interlinked length is typically significantly shorter than that of the total field measured length of the SCC colony. There are a total of 87 unreported SCC colonies depicted in Figure 4.37, which, based on their total field measured length, could be classified as false negative features; however, only two of those SCC colonies should be classified as false negative features based on their field-measured interlinked lengths. There were an additional 11 unreported SCC colonies whose total length exceeded the tool reporting threshold but for which there were no field measured interlinked lengths provided. In order to be conservative, these 11 SCC colonies were also classified as false negative features. As shown previously in Figure 4.35, the lowest predicted failure pressure of these 13 false negative SCC features is equal to 140% the NEB-approved MOP, while the shortest remaining life of these 13 features is 69 years, as shown in Table 4-11. Thus based on this information, SCC colonies not reported by the crack detection tool can be managed through ILI feature detection enhancements and subsequent ILI and pipeline rehabilitation, and do not pose an immediate threat to the integrity of the pipeline.

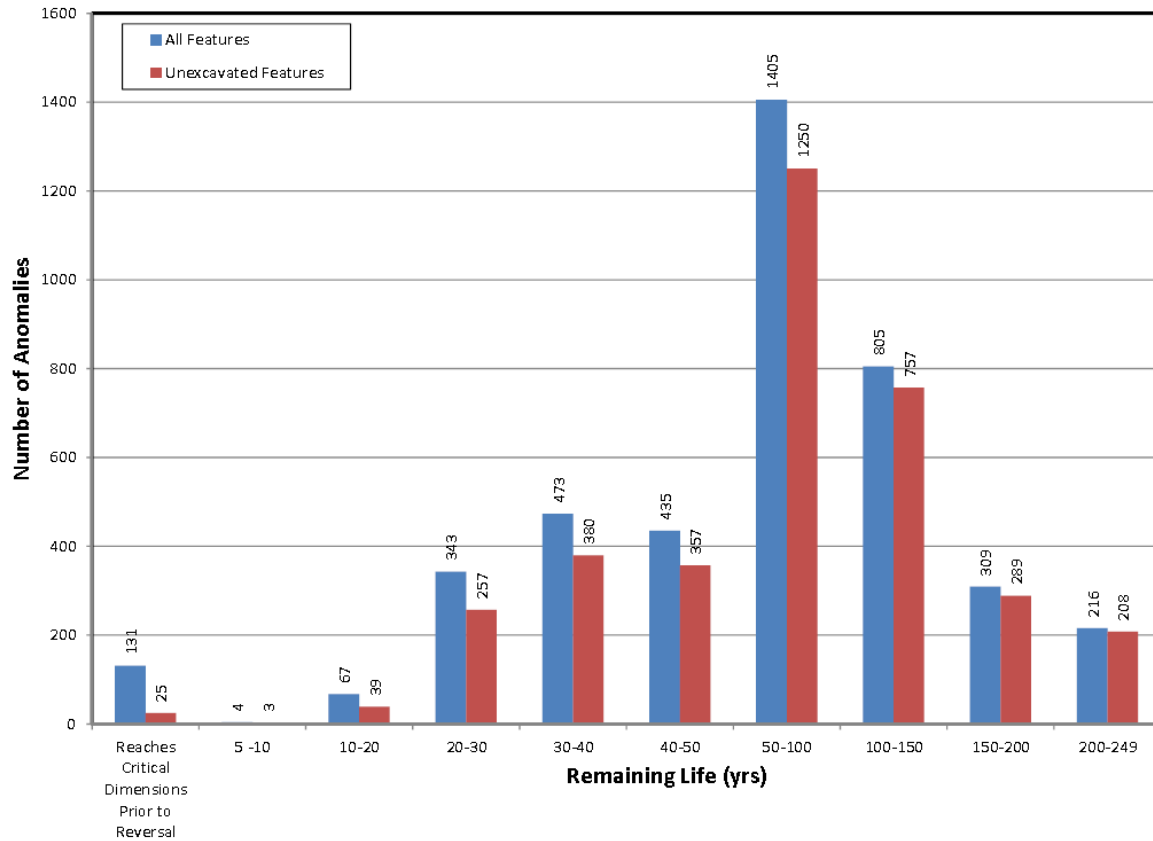
**Figure 4.46 - Deterministic Remaining Life Assessment
of USCD Reported Features in Line (NW-ML)**

Provided in Figure 4.46 is a graphical depiction of the calculated remaining lives of the reported crack related features in Line 9B between NW and ML. Based on the analysis discussed above, there are presently 25 reported features that are predicted to reach critical dimensions prior to the proposed flow reversal in October 2013. However, based on the current reduced operating pressures that Line 9B is operating under, none of the features would be expected to reach critical dimensions until December 2013. Enbridge is presently in the process of re-inspecting Line 9B between NW and ML and these 25 features will be re-evaluated based upon the new inspection data and repaired as required prior to the reversal of Line 9B. Any feature meeting excavation criteria will be repaired in order to operate the line at the required operating parameters prior to line reversal.

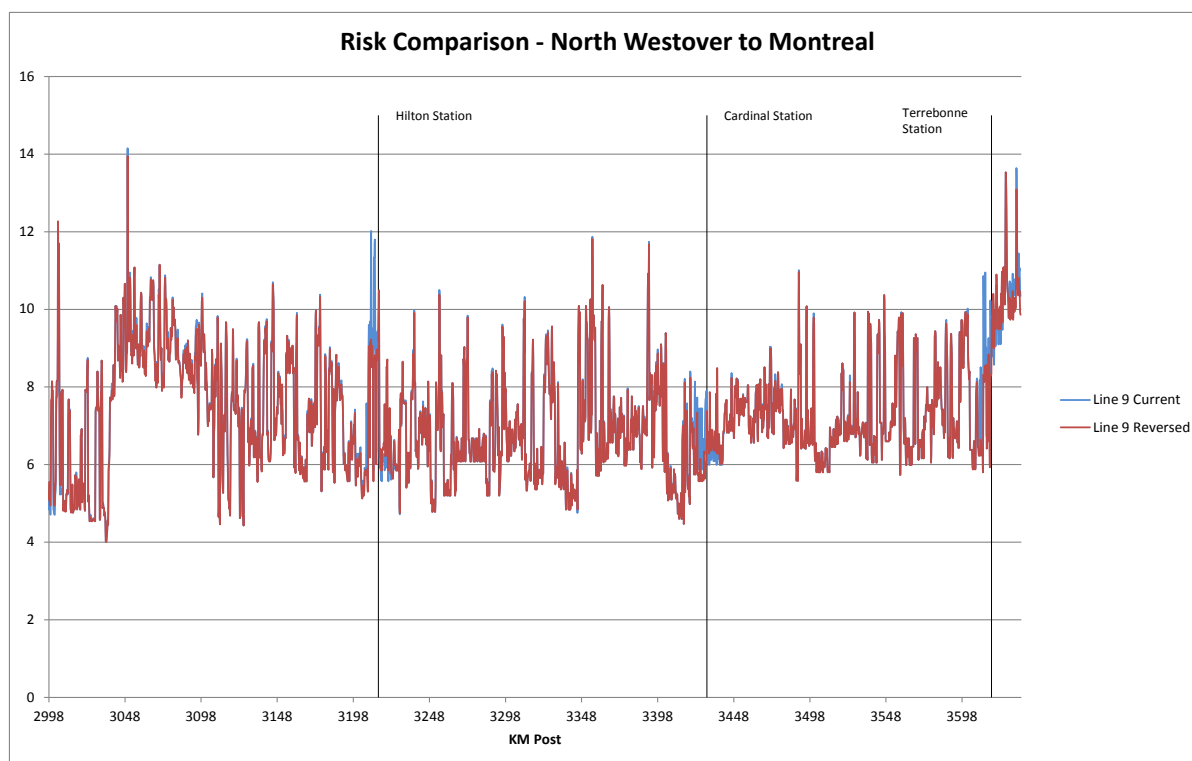
Figure 4.47 - Risk Profile for Line 9B (NW-ML) Pre and Post Flow Reversal

The cracking risk profile associated with the portion of Line 9B between NW and ML, pre and post flow reversal, is depicted graphically in Figure 4.47. The risk profile was determined by Enbridge's Operational Risk Management specialists.

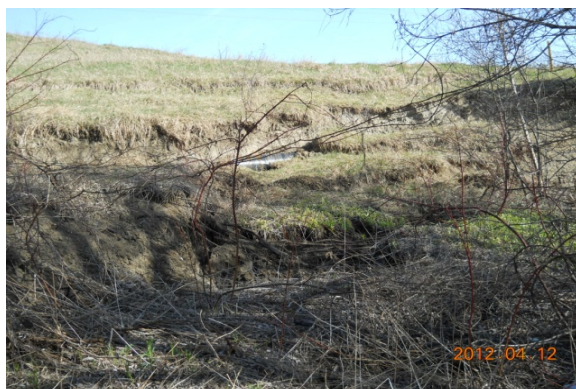
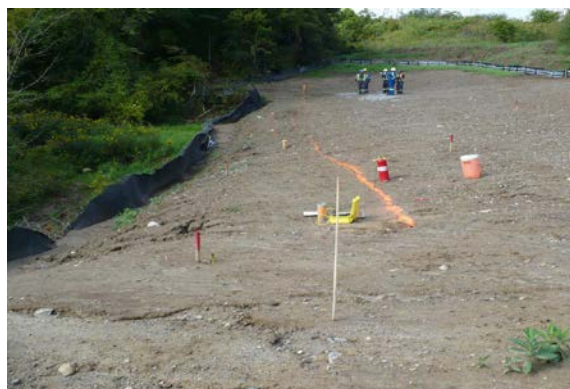
In October 2012, during planned ROW maintenance at the site, pipeline movements in the order of 400mm in the downslope direction were observed. While the corresponding strains were acceptable, in order to be conservative, a second stress relief was conducted. Inspections of the girthwelds within the movement zone accompanied the stress relief to allow for identification and repair of any anomalies. This ensured that the pipe section may safely accommodate potential future longitudinal strain and movement levels. Backfilling was completed in November 2012, and vertical monitoring tubes were installed to allow for direct monitoring of the pipe position. In consideration of the movement rates at the East Don River approach slope, Enbridge is planning to conduct a pipeline relocation from this site in 2013. Planning and preparation for the required permitting process is currently underway. The pipeline strain and position will continue to be monitored at scheduled intervals. Remediation will be conducted as required should the pipeline strains approach the allowable limits prior to the relocation.
