SELF-ASSESSMENT AND RISK MANAGEMENT DECISION FRAMEWORK FOR DFO REGULATORY REQUIREMENTS

Watercourse (Site#): Montgomery Creek (SK-WC78)
Legal Location: 14-4-13-3 W2M
UTM (Zone 13U): 688727E, 5548559N
SKP (as of June 2014): 890.8

Line 3 Replacement Program

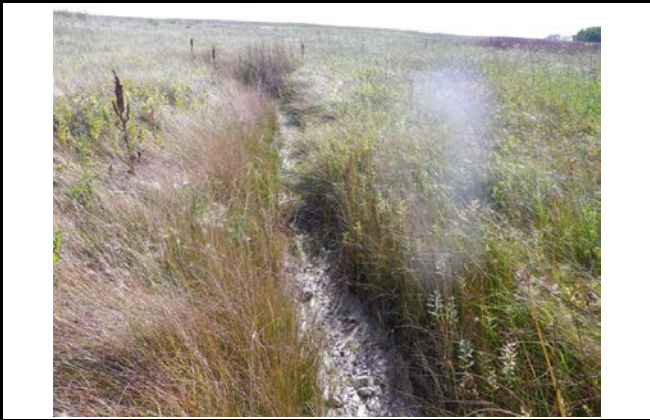
ADDITIONAL HABITAT COMMENTS
Dry at time of assessment. Intermittent sections of defined and undefined channel. Cattle impacts evident including at right-of-way centerline. Previous information indicates fish presence and wetter conditions in the spring.

Plate 6 Photograph taken approximately 100 m downstream of the right-of-way looking upstream at dry channel section.

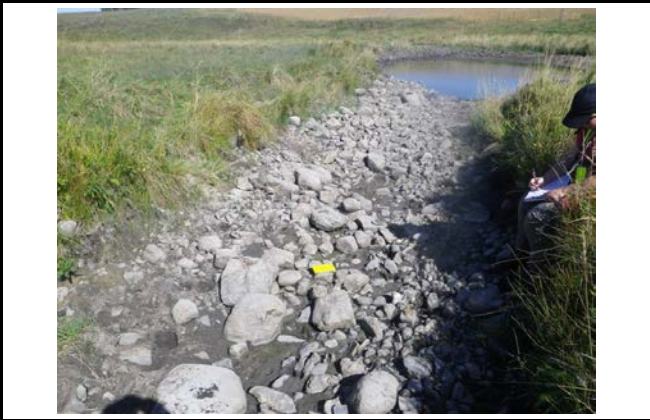
ADDITIONAL HABITAT COMMENTS
Isolated pond present within right-of-way where fish were captured and observed. No defined channel at centreline. Dry for remainder of study area at the time of assessment. Sections of dry defined channel and undefined channel. Cattle impacts evident. Dissolved oxygen reading taken with HACH test kit.

Plate 6 Photograph taken approximately 25 m upstream of the right-of-way looking downstream

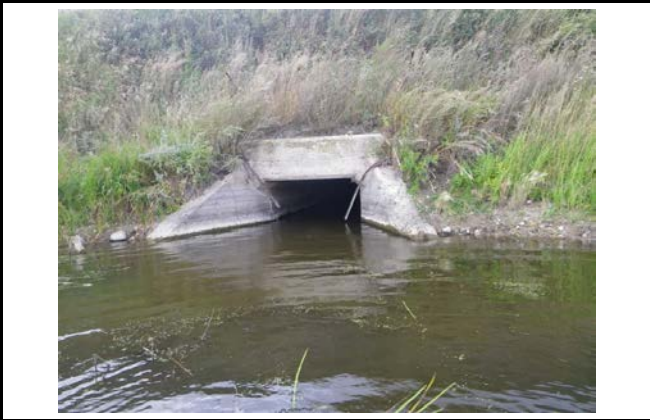
ADDITIONAL HABITAT COMMENTS
Cattle impacts are evident. No defined channel with limited connectivity. Railway culvert crossing present 50 m downstream causes ponding effects. Instream vegetation present as cover. Dissolved oxygen reading taken with HACH test kit.

Plate 6 Photograph taken approximately 25 m downstream of the right-of-way looking downstream at culvert railroad crossing.

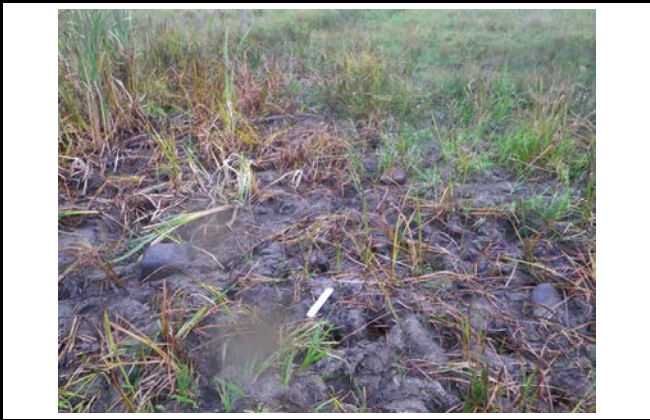
Plate 6 Photograph taken approximately 40 m upstream of the right-of-way looking at left bank showing cattle impacts.

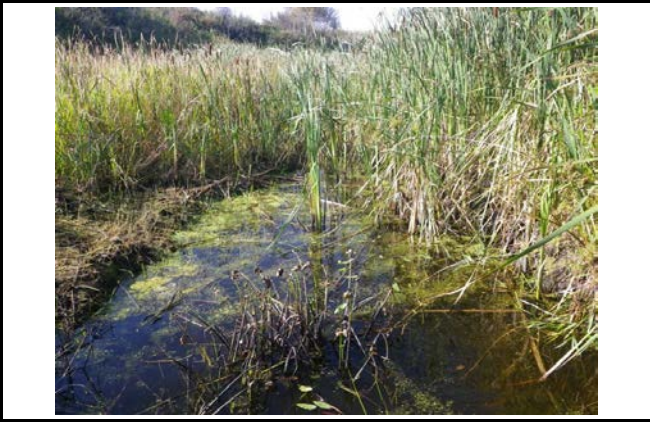
Plate 6 Photograph taken approximately 25 m upstream of the right-of-way looking upstream at ponding.

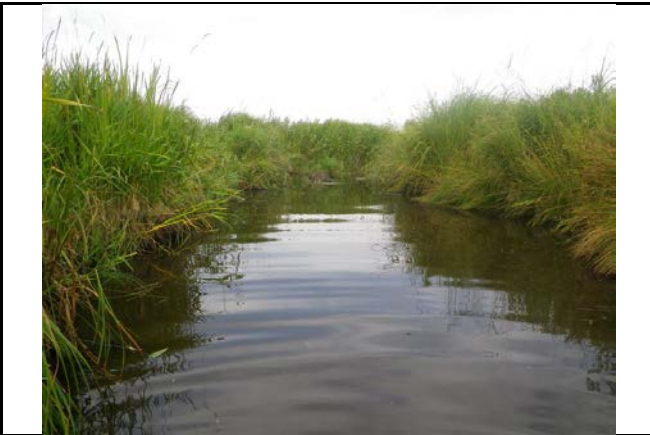
Plate 6 Photograph taken approximately 100 m downstream of the right-of-way looking upstream (deep pool is visible through the vegetation).

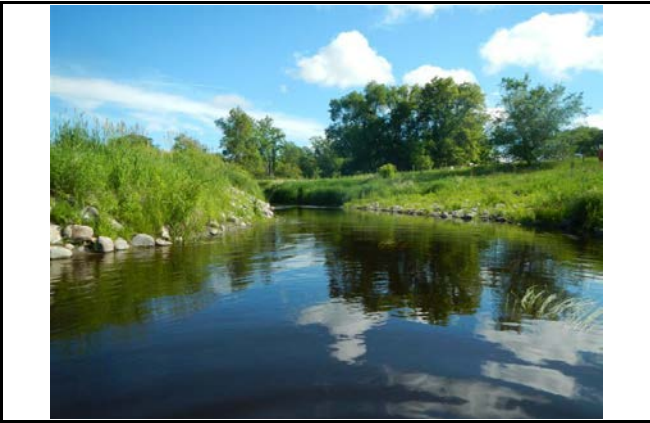
Plate 2 Photograph taken at right-of-way looking downstream and toward suggested alternate right-of-way.

ADDITIONAL HABITAT COMMENTS	
Wabash pigtoe, white heelsplitter, cylindrical papershell, giant floater and fatmucket have all been previously documented (Watson <i>et al.</i> 1998). The current proposed right-of-way is on a meander bend. Right bank is relatively unstable at 50 m upstream of right-of-way. Very good habitat throughout reach, although overwintering potential is limited within assessment reach. Over 1000 minnows were observed, most likely fathead minnows. 10 small mussels were found after sampling 20 m² 100 m and 150 m downstream of proposed right-of-way, and it is expected that mussels would be found in sandy/muddy areas throughout entire study reach. It is recommended that a mussel salvage be done.

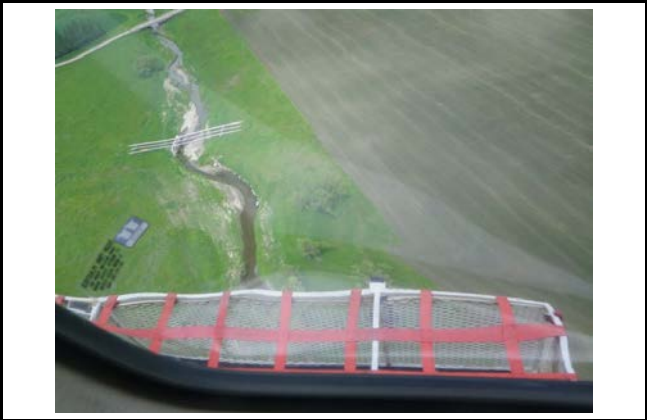
ADDITIONAL HABITAT COMMENTS
No land access in July 2013. Bank armoring present on right bank within right-of-way. Overhead pipeline crossing present at 50 m downstream. Flood signs are present, showing evidence of high flows. Banks are unstable at some locations within the study area. Limited overwintering habitat potential for large-bodied fish species due to depth. There were five fatmucket mussels captured and observed both upstream and downstream of the right-of-way.

Plate 5 Aerial photograph of crossing view north showing existing aerial pipeline crossing (June 26, 2013).
