LINE 9B REVERSAL AND LINE 9 CAPACITY EXPANSION PROJECT

PIPELINE INTEGRITY ENGINEERING ASSESSMENT

Submitted to:
NATIONAL ENERGY BOARD

Prepared by:
Enbridge Pipelines Inc. Pipeline Integrity Department

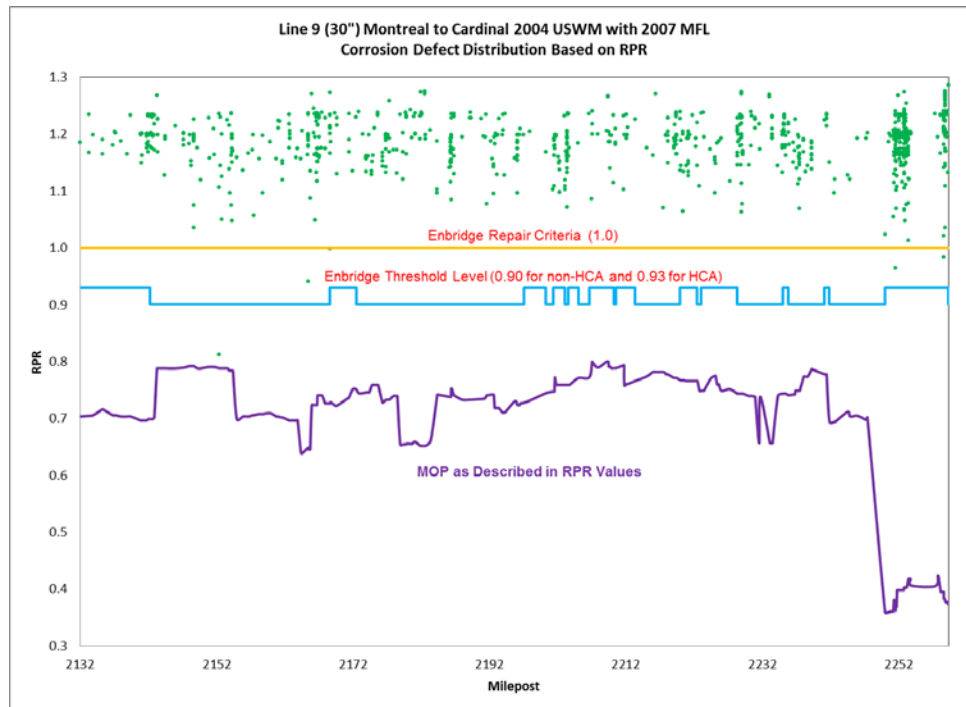
Figure 4.8 - Line 9 (ML – CD) – Predicted Metal Loss Failure Pressure

Figure 4.8 shows the corrosion defect distribution based on RPR on the ML to CD segment of this pipeline. The reader will observe areas that appear to depict high-density corrosion between

MP 2252 and the Montreal Terminal at MP 2260. This is an effect of the scale of the chart, and does not indicate real-world corrosion density

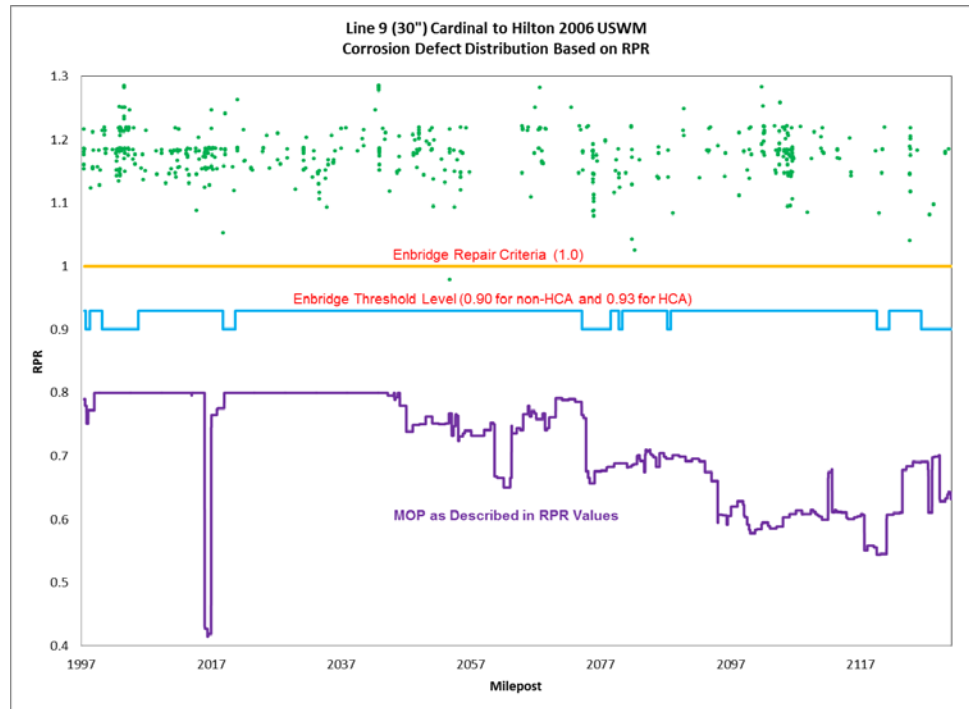
- 1 **Figure 4.9 - Line 9 (CD – HL) – Predicted Metal Loss Failure Pressure**
- 2 Figure 4.10 shows the corrosion defect distribution based on RPR for the HL-NW segment of
- 3 this pipeline.

Figure 4.9 shows the corrosion defect distribution based on RPR on the CD-HL segment of this pipeline.

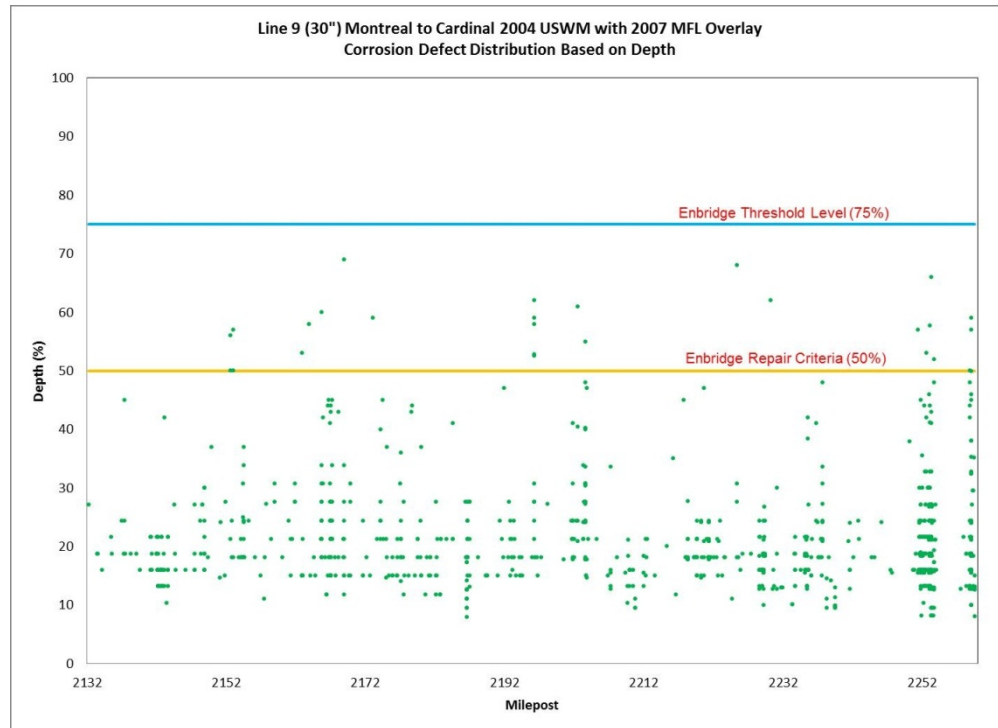
Figure 4.11 - Line 9 (ML – CD) – Metal Loss Depth Distribution

Figure 4.11 shows the corrosion defect distribution based on depth on the ML to CD segment of this pipeline. The areas between MP 2252 and Montreal Terminal (MP 2260) appear to depict high-density corrosion; however this is an effect of the scale of the chart, and does not indicate real-world corrosion density.

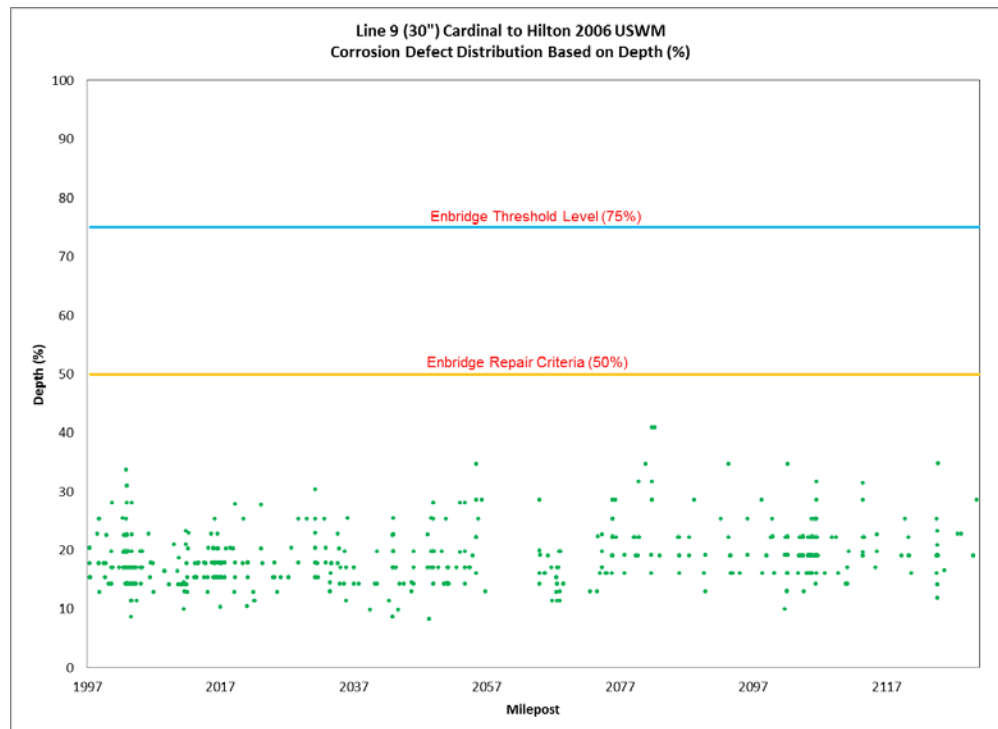
Figure 4.12 - Line 9 (CD – HL) – Metal Loss Depth Distribution

Figure 4.12 shows the corrosion defect distribution based on depth for the CD-HL segment of this pipeline.

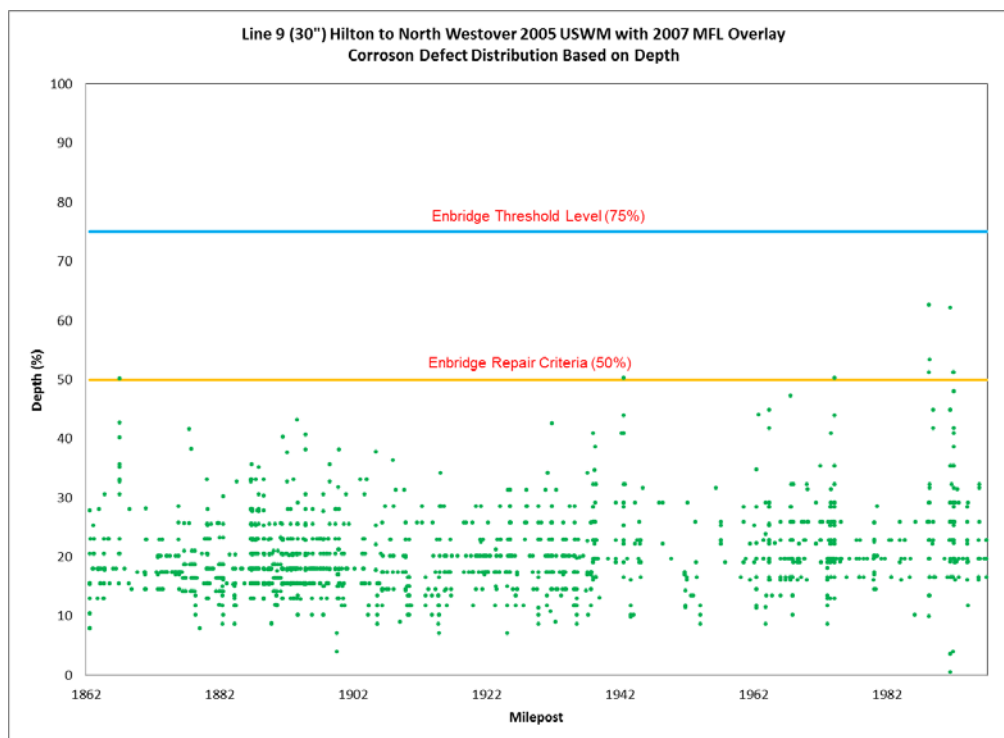
Figure 4.13 - Line 9 (HL – NW) – Metal Loss Depth Distribution

Figure 4.13 shows the corrosion defect distribution based on depth for the HL-NW segment of this pipeline.

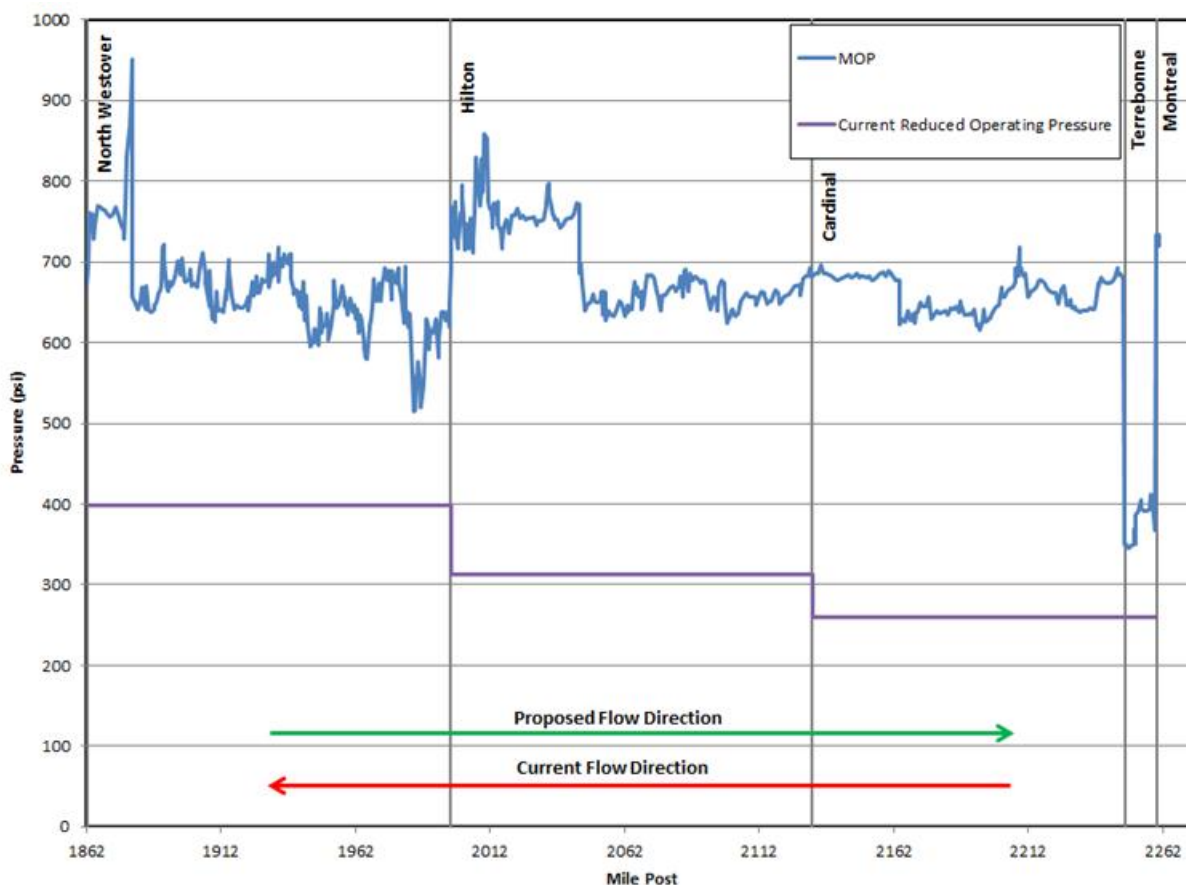
Figure 4.26 - NEB-Approved MAOP / Current Reduced Operating Pressure vs. Mile Post (NW-ML)

18 Enbridge's excavation and repair programs associated with crack management are based in part
19 on a safety factor approach where the reference level is the NEB-approved MOP as determined
20 from the original commissioning hydrostatic test; there is no consideration for actual "at-site"
21 operating pressures that lie below these NEB-approved MOP values. The current NEB-approved
22 MOP values will not be altered by the proposed flow reversal or capacity increase and, thus, the
23 excavation and repair programs will not require any modifications following the reversal. As
24 there will be no increase in the normal discharge pressures associated with the pump stations,
25 when the proposed flow reversal occurs, pending approval, all of the at-site pressure profiles will
26 lie below the NEB-approved values as shown in Figure 4.26. For operational reasons, Line 9B
27 has been operating at reduced pressures since September 2010; the magnitude of the current

28 pressure reductions are 30% SMYS at Terrebonne, 36% SMYS at Cardinal and 46% SMYS at
29 Hilton.

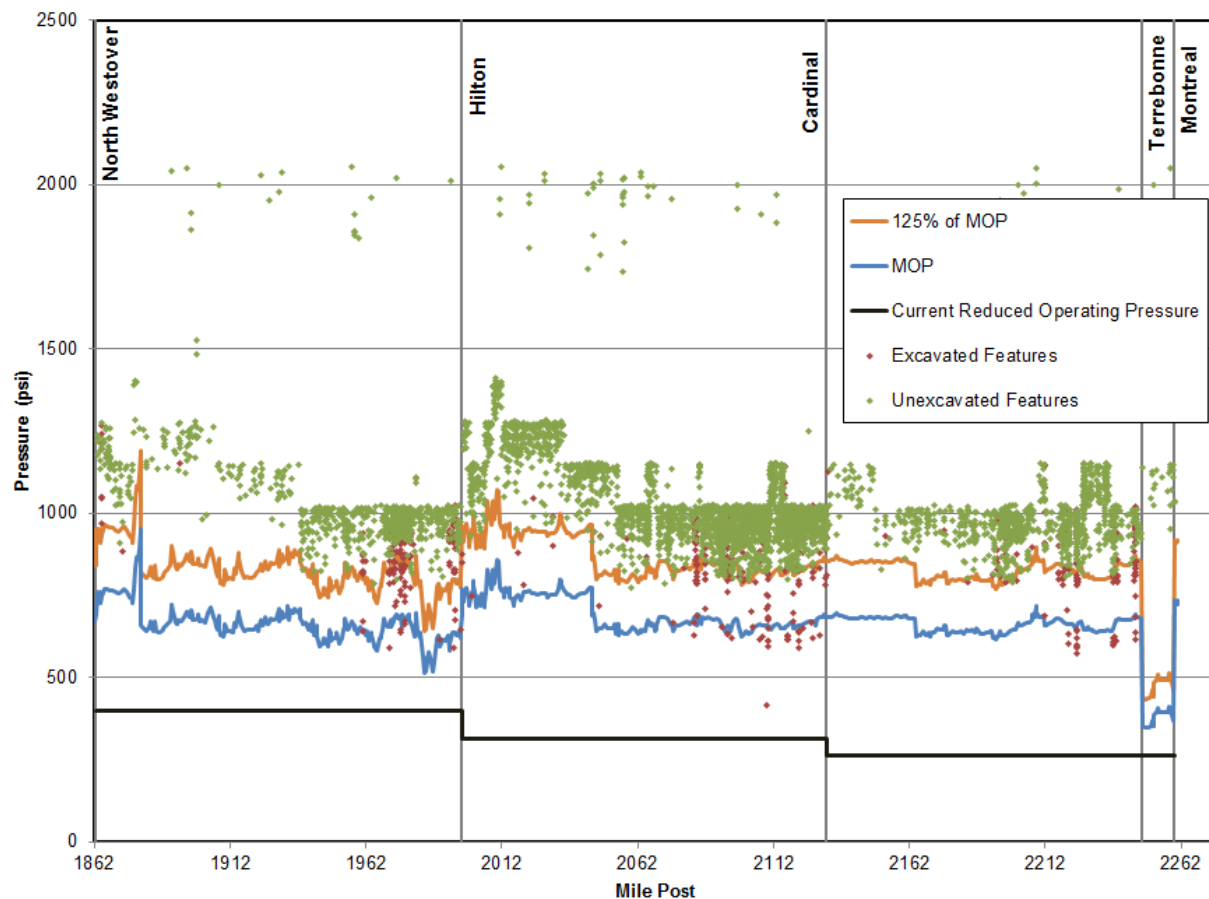
Figure 4.34 - Predicted Failure Pressures, All Reported Features (NW-ML)

Based upon the above input assumptions, there were a total of 184 features on 149 joints that had a predicted failure pressure less than 125% of the MOP, shown in Figure 4.34. 172 of these 184 features have been subsequently excavated. The lowest predicted failure pressure of these reported features is 663 psi which equates to 86.3% of the NEB-approved MOP or 212% of the current reduced operating pressure. The vast majority of the features (82%) remaining in the pipeline have predicted failure pressures higher than 140% of the NEB-approved MOP. Enbridge is presently inspecting Line 9B between NW and ML, and these features will be re-evaluated based upon the new inspection data.

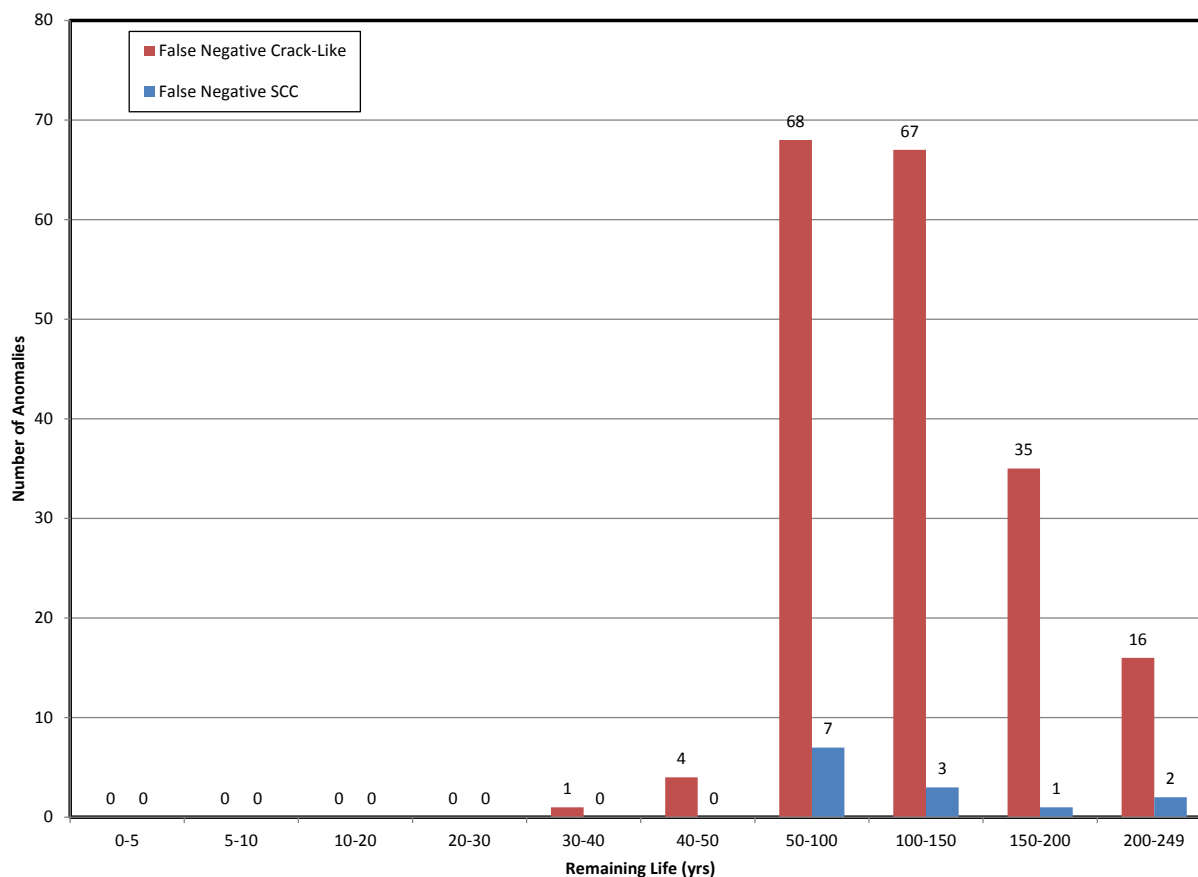
Figure 4.36 - Calculated Remaining Lives of False Negative Features

Shown in Figure 4.35, the lowest predicted failure pressure of the 193 false negative CL features is equal to 125% of the NEB-approved MOP, while the shortest remaining life of these 193 features is 36 years (refer to Figure 4.36 and Table 4-10). Thus, based on this information, CL features not reported by the crack detection tool can be managed through ILI feature detection enhancements, subsequent ILI, and pipeline rehabilitation, and do not pose an immediate threat to the integrity of the pipeline.

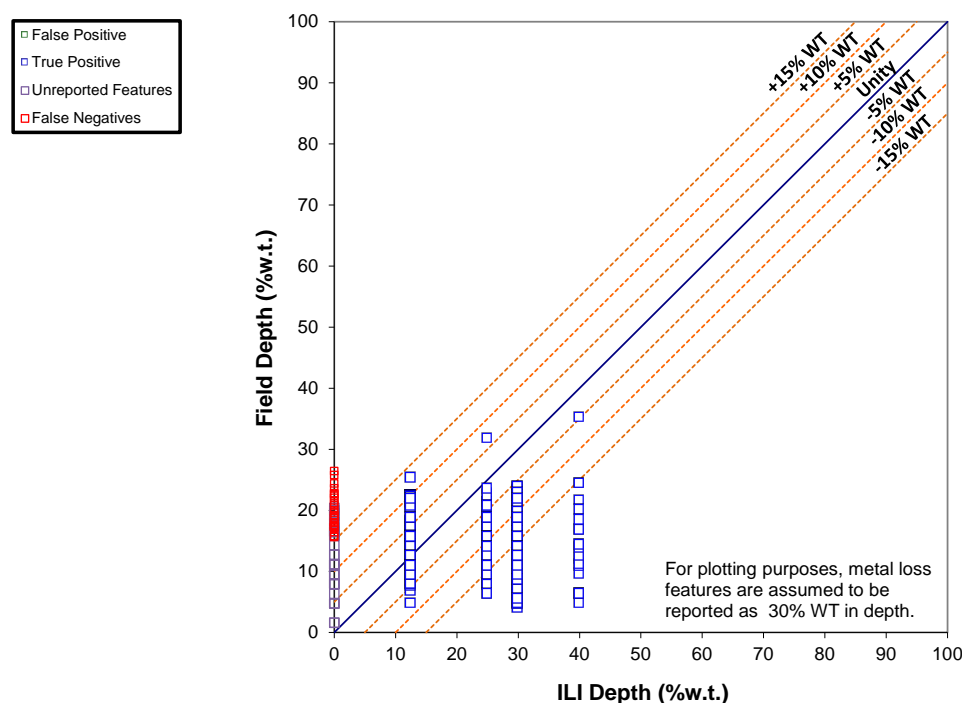
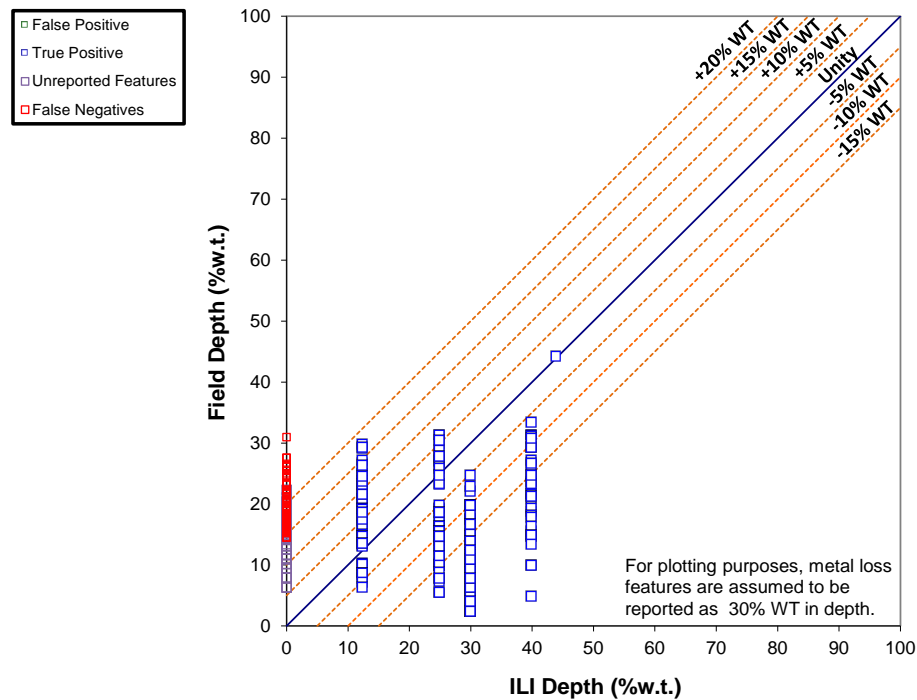
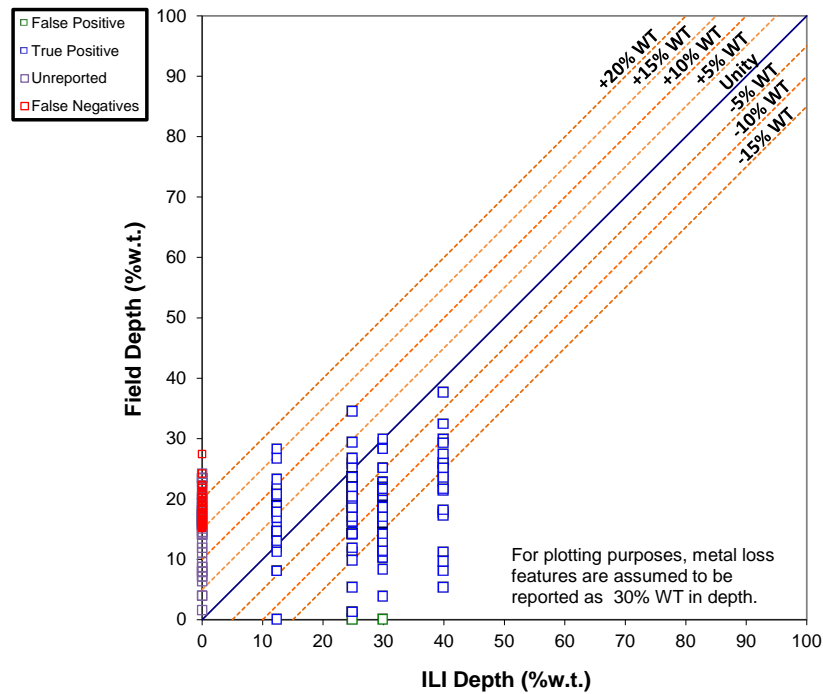
Illustrated in Figures 4.38, 4.40 and 4.42 the USCD has challenges accurately sizing features with a reported depth $< 12.5\%$ of the pipe WT. This coincides with Enbridge’s and industry’s experience. These challenges are understandable since this depth is below the actual reporting threshold of the tool. However, the GE UltraScanTM Crack Detection tool was able to accurately or conservatively size those features with a reported depth $> 12.5\%$ of the pipe WT, which are the features that are in fact above the reporting threshold of the tool, as summarized below.

Although the GE UltraScanTM Crack Detection tool did not provide depths for the reported metal loss features, Figures 4.38, 4.40 and 4.42 illustrate that the field-measured depths corresponding to those features varied from 2% to 30% of the pipe WT.

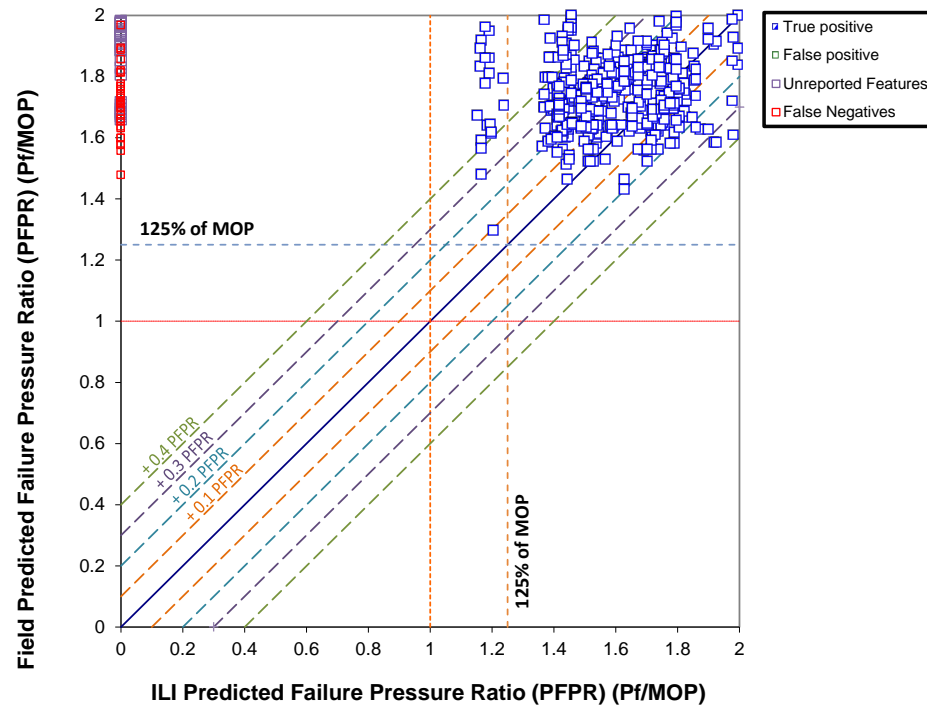
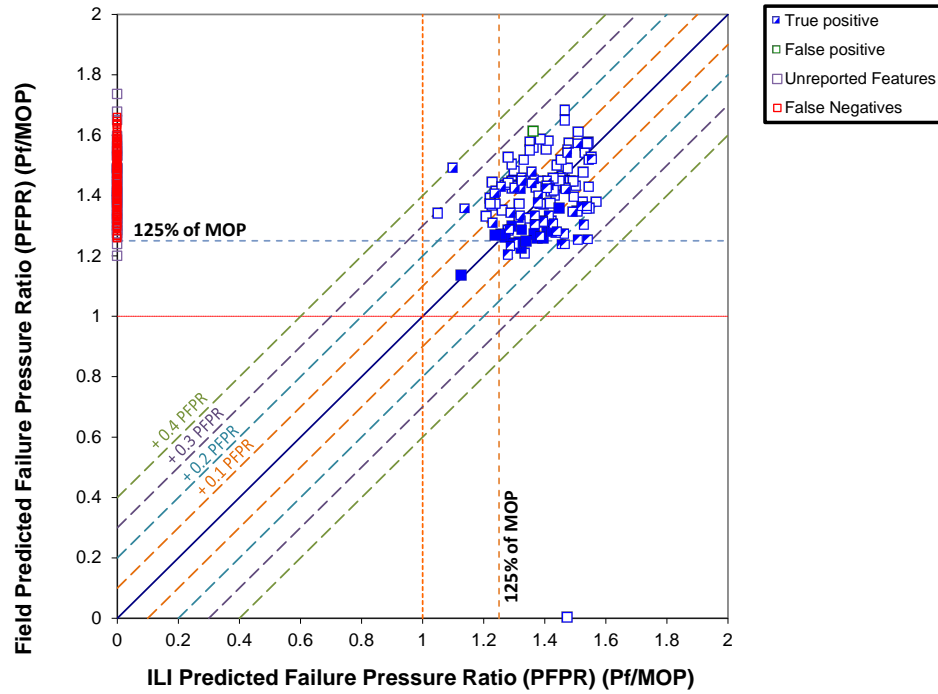
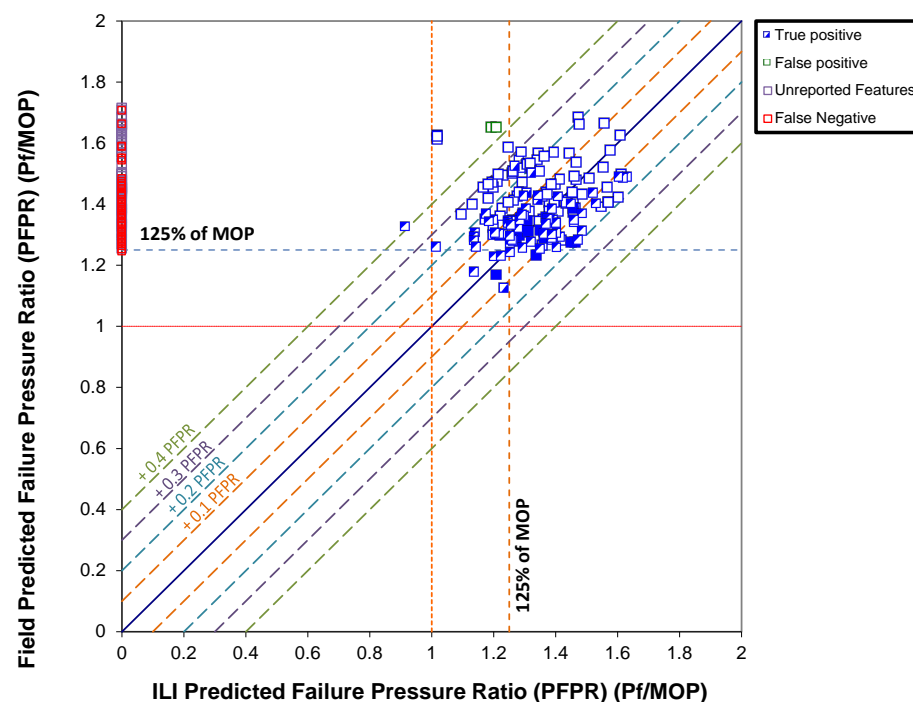
Figures 4.39, 4.41 and 4.43 illustrated that there is considerable scatter in the field-predicted failure pressure ratios relative to the corresponding tool-predicted failure pressure ratios. Some of this scatter can be attributed to the manner in which the field NDT contractor measured and recorded the lengths of the field detected features. Subsequent to the completion of the excavation programs on these three segments of Line 9B, Enbridge developed and implemented detailed reporting requirements that field NDT contractors must adhere to when recording measurements of field detected features. These requirements have reduced the amount of scatter in the field-tool correlations involving predicted failure pressure ratios.

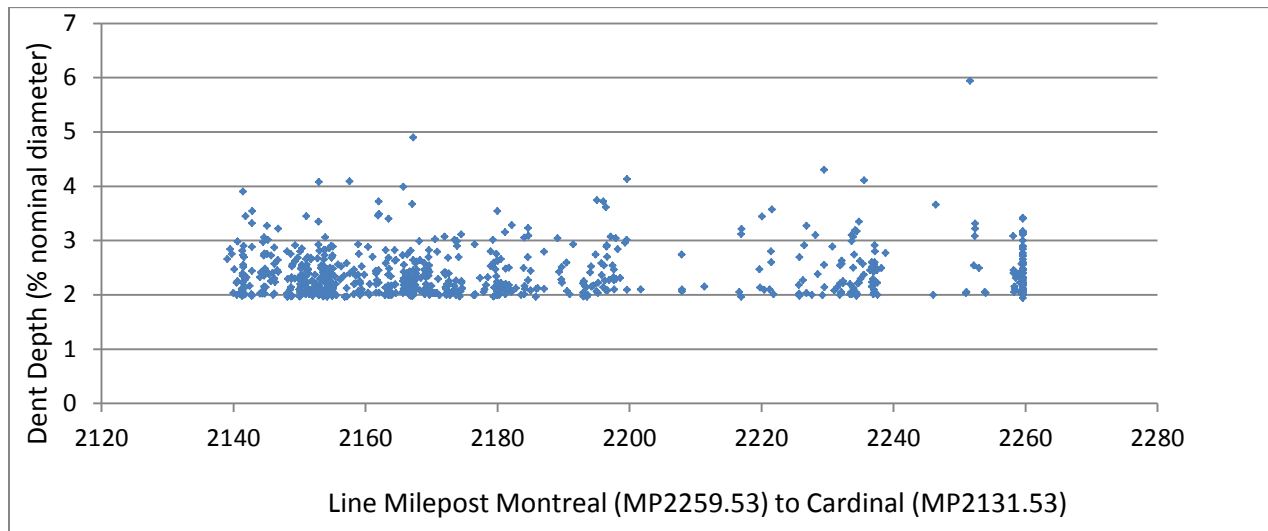
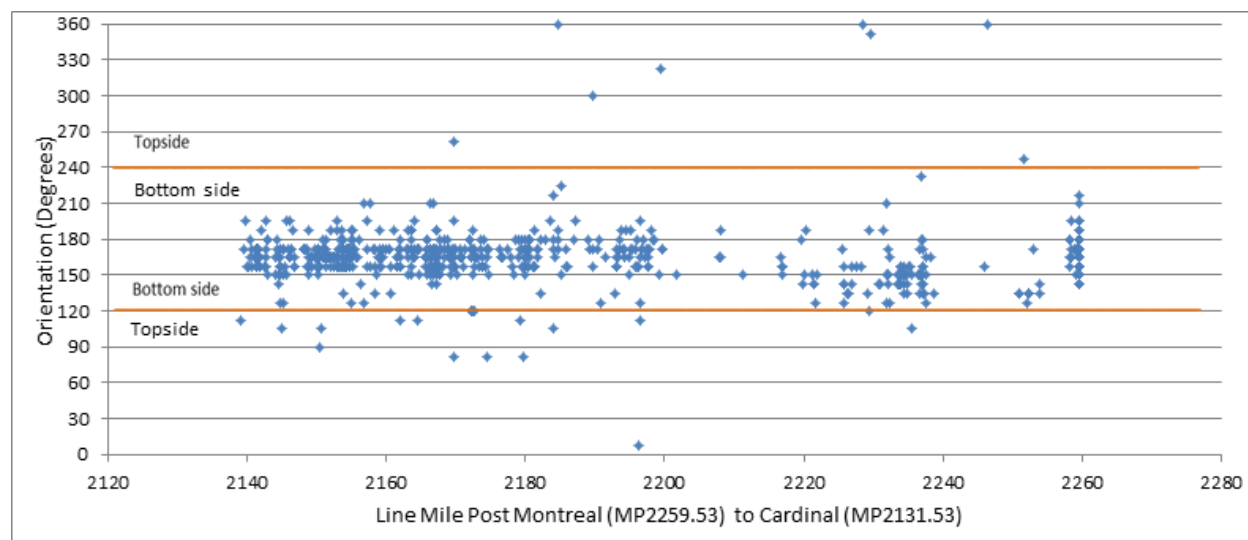
The segment between ML to CD stations was last inspected by a mechanical damage tool in 2007 by a GE CXR. Figures 4.48 and 4.49 illustrate the distribution of the features reported by the inspection. Figure 4.48 demonstrates the depth of the reported dents by Milepost, and Figure 4.49 demonstrates the orientation of the reported dents by Milepost.

The results of the 2007 GE CXR identified 12 features to be excavated, 11 because they met the excavation criteria and one for validation. The 12 features were excavated, field assessed and repaired according to Enbridge repair criteria.

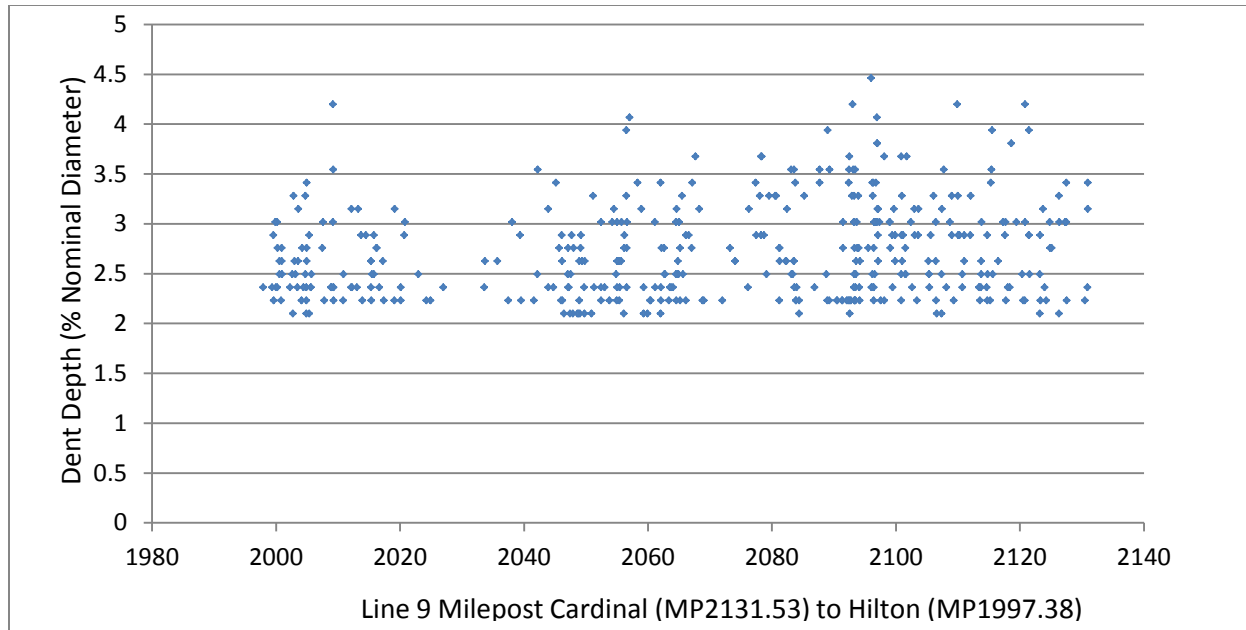
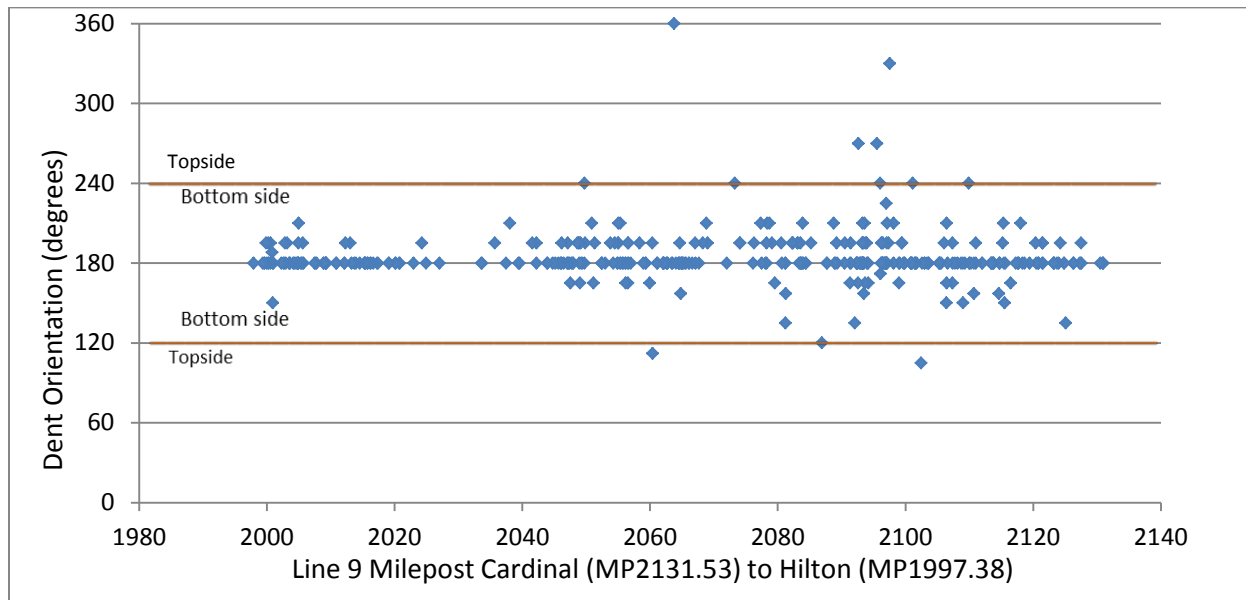
The most recent caliper inspection of the pipeline segment between CD to HL stations was performed in 2000 by the BJ Geopig tool. Figures 4.50 and 4.51 illustrate the distribution of the reported features by the 2000 Geopig greater than 2% of nominal diameter over the length the segment from CD to HL. Figure 4.50 demonstrates the depth of the reported dents by Milepost, and Figure 4.51 demonstrates the orientation of the reported dents by Milepost.

Nine mechanical damage digs resulted from the 2000 BJ Geopig data, all of which were for reported topside plain dents. The field assessments and NDE confirmed the ILI data with six plain topside dents. The nine features were excavated, field assessed and repaired based on Enbridge repair criteria.

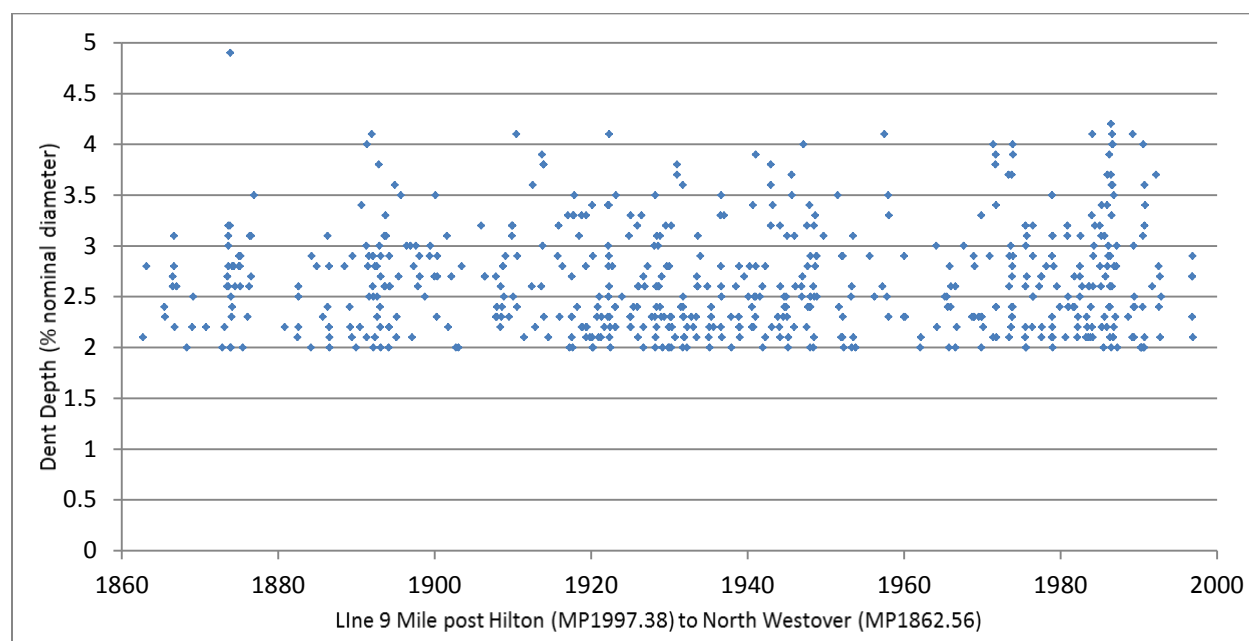
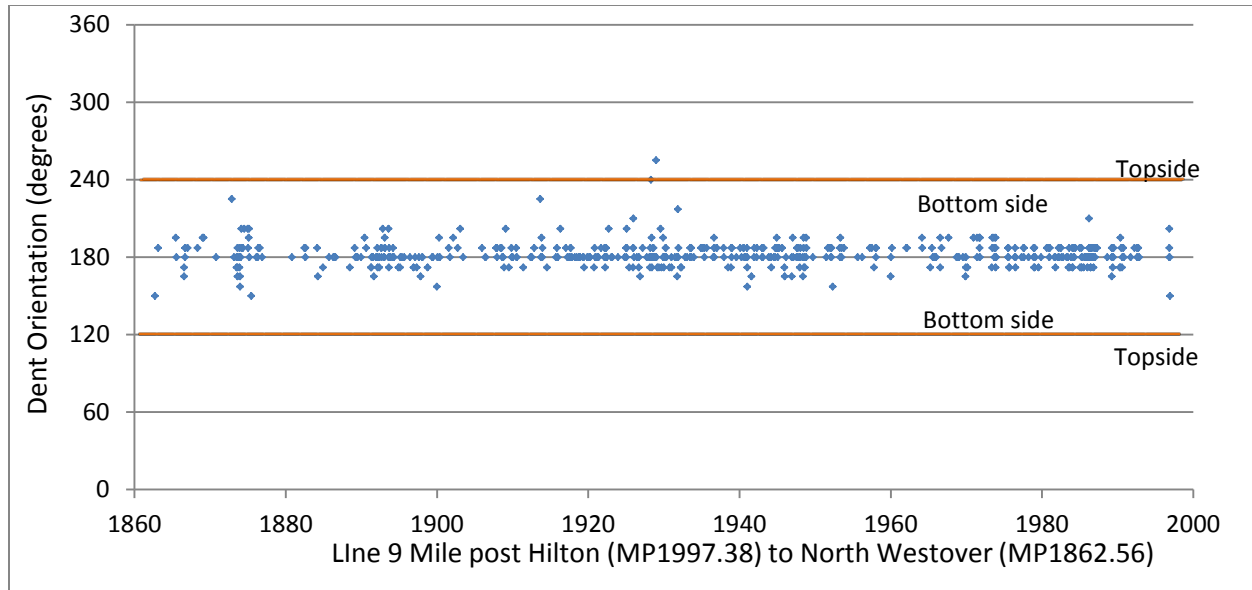
In 2005, a caliper inspection was performed on the HL to NW segment by a BJ Geopig. Figures 4.52 and 4.53 illustrate the distribution of the reported features by the 2005 Geopig greater than 2% of nominal diameter over the length the segment from HL to NW. Figure 4.52 demonstrates the depth of the reported dents by Milepost, and Figure 4.53 demonstrates the orientation of the reported dents by Milepost.

No features that meet excavation criteria were identified in the 2005 BJ Geopig inspection.
